JOINT INVESTIGATION REPORT

INCIDENT NO: 2212431 JIV report S/N: 0182

3. Name of Location 28" BOMU - BONNY TRANS NIGER PIPELINE

8. Asset owner/District THE SHELL PETROLEUM DEVELOPMENT COMPANY OF NIGERIA LIMITED PIPELINE

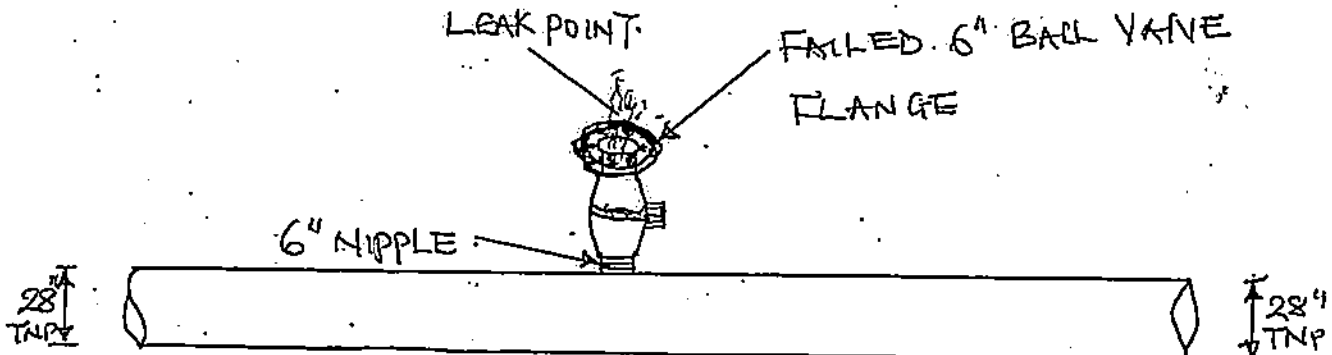
| <input checked="" type="checkbox"/> Failed Weld-on illegal hot tap valve | <input type="checkbox"/> Failed Clamp | <input type="checkbox"/> Missing Pipeline/Flowline |
| <input checked="" type="checkbox"/> Crude oil theft (illegal bunkering) point | <input type="checkbox"/> Saver-pit over flow | <input type="checkbox"/> Third party tampering with Clamp |

**SECTIONAL VIEW OF 28" BOMU - BONNY TRANS NIGER PIPELINE
AT OKOKIRI, SHOWING: FAILED 6" WEID-ON ILLEGAL HOT
TAP VALVE INSTALLED AT 12 O' CLOCK POSITION BY
UNKNOWN PERSON(S)**

TEMPORARY REPAIR BY BLIND FLANGING THE THEFT POINT ONGOING AND WAS COMPLETED.

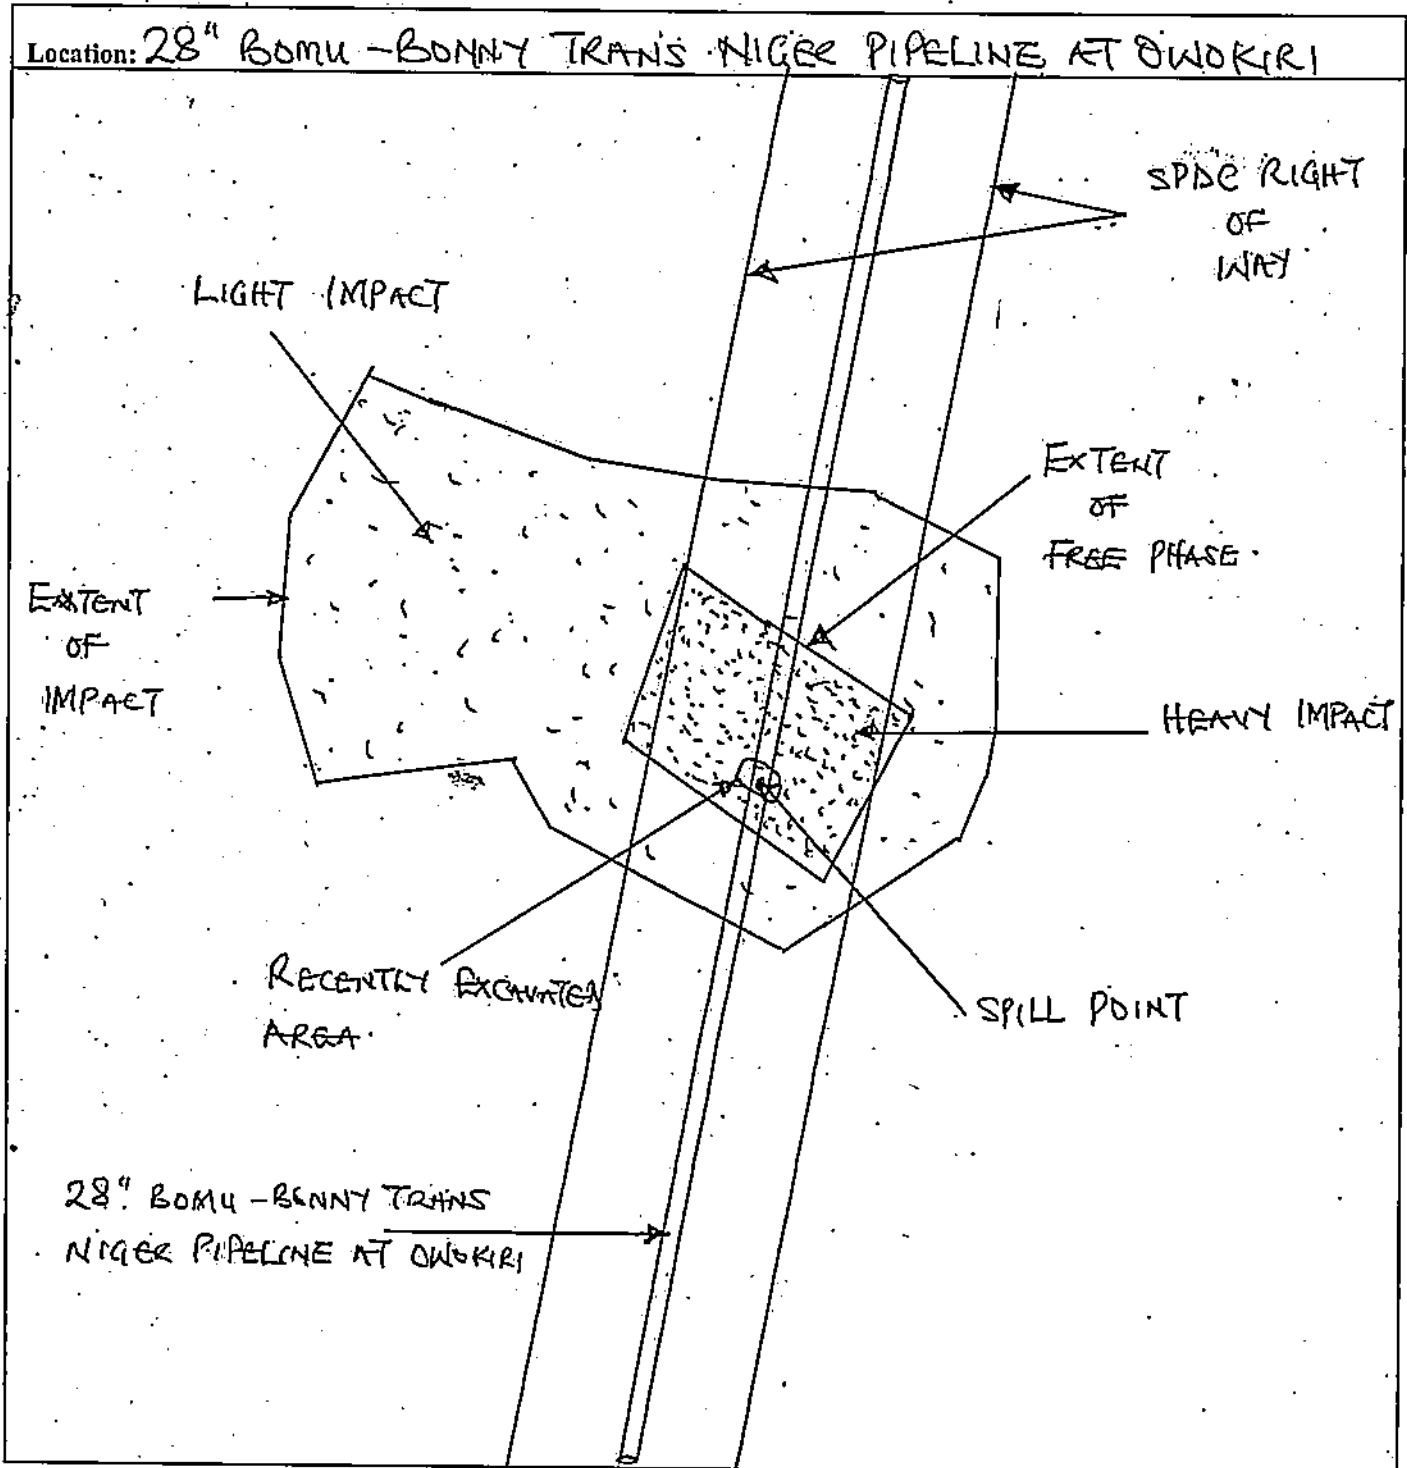
f. Appendix 1: Overview sketch of the site

- Total calculated area of impact 1.1643 Ha
- Impact within R.O.W YES
- Impact outside R.O.W YES
