# JOINT INVESTIGATION REPORT

INCIDENT NO: 2215966 JIV report S/N: 0189

- 1. Spill incident Number: 2215966      2. Type of incident\*: OIL SPILL
- 3. Name of Location 28<sup>th</sup> NKPOKY - BONNU PIPELINE
- 4. Name of nearest community RUMUOWHA CENEKAS      5. State: RIVERS      6. LGA OBIO AKPOR
- 7. Type of Production facility/Installation OIL PIPELINE
- 8. Asset owner/District THE SHELL DEVELOPMENT PETROLEUM DEVELOPMENT COMPANY OF NIGERIA LIMITED / PIPELINE

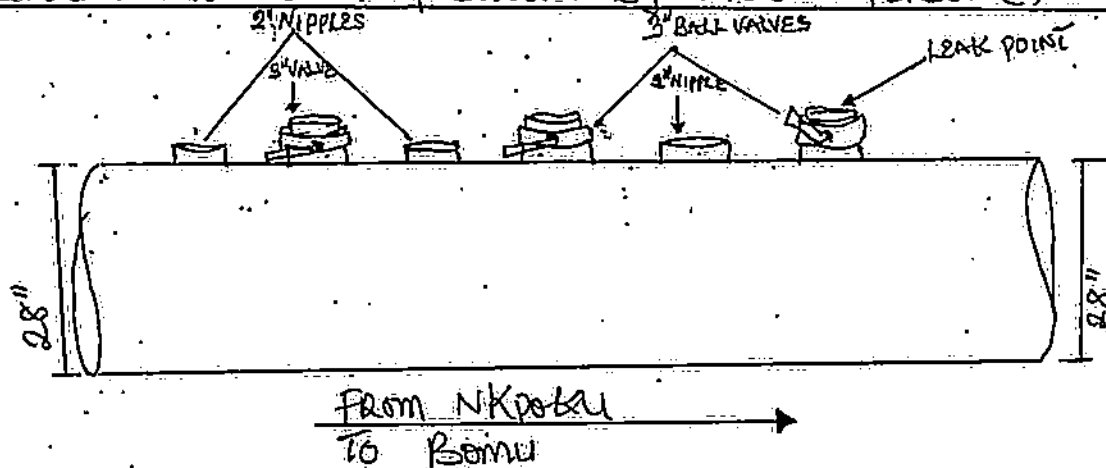
**E. GRAPHIC DESCRIPTION OF LEAK POINT** (while detailed report of the leak point should be contained in the leak report, overview sketch of the site should be added as an appendix 1)

Additional observations around the spill point: SAND BAGS CONCEALING CRUDE OIL THEFT POINT WAS OBSERVED BY THE JOINT INVESTIGATION TEAM.

| <input checked="" type="checkbox"/> Failed Weld-on illegal hot tap valve | <input type="checkbox"/> Failed Clamp | <input type="checkbox"/> Missing Pipeline/Flowline |
| <input checked="" type="checkbox"/> Crude oil theft (illegal bunkering) point | <input type="checkbox"/> Saver-pit over flow | <input type="checkbox"/> Third party tampering with Clamp |

SECTION OF 28" NKPOKU - BOMU PIPELINE AT RUMUOWHA (ENEKA) SHOWING GNOB OF THEIR INSTALLATION AT 12 O'CLOCK POSITIONS BY UNKNOWN PERSON(S)

RECOVERY AND REPAIR ACTIVITIES ARE ONGOING
