# JOINT INVESTIGATION REPORT

INCIDENT NO: 2213884 JIV report S/N: 0183

1. Spill incident Number: 2213884 2. Type of incident\* OIL SPILL  
3. Name of Location 24" BOMU - BONNY TRANS NIGER PIPELINE  
4. Name of nearest community OKIOKIRI 5. State: RIVERS 6. LGA ANDONI  
7. Type of Production facility/Installation OIL PIPELINE

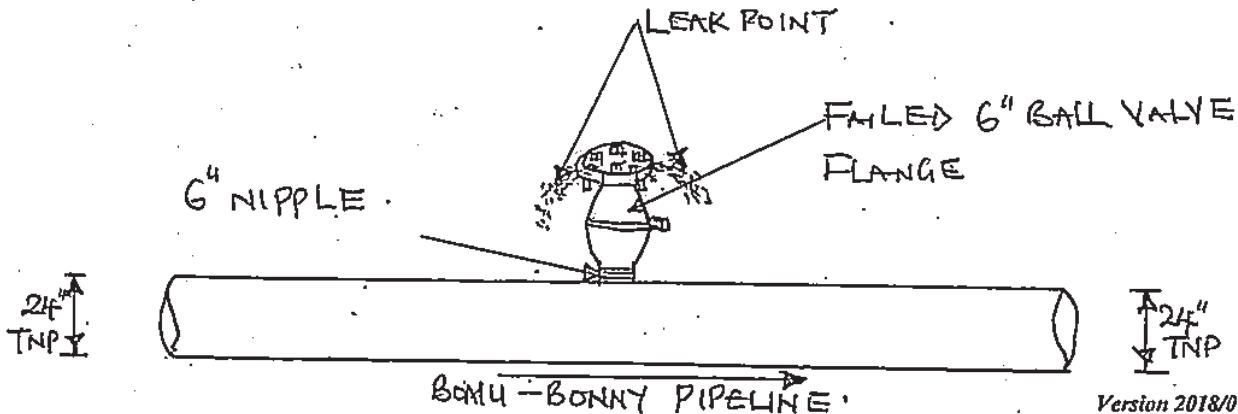
SECTIONAL VIEW OF 24" BOMU - BONNY TRANS NIGER PIPELINE AT OKOKIRI SHOWING: - FAILED 6" WELD-ON ILLEGAL HOT TAP VALVE INSTALLED AT 12 O' CLOCK POSITION BY UNKNOWN PERSON(S)
