JOINT INVESTIGATION REPORT

INCIDENT NO: 2208952 JIV report S/N: 0162

1. Spill incident Number: 2208952 2. Type of incident*: OIL SPILL
3. Name of Location 16" EGBEMA - ASSA PIPELINE
4. Name of nearest community UMUDIKE 5. State: IMO 6. LGA OHAJI/EGBEMA
7. Type of Production facility/Installation OIL PIPELINE
8. Asset owner/District THE SHELL PETROLEUM DEVELOPMENT COMPANY OF NIGERIA LTD (SPDC) / PIPELINE

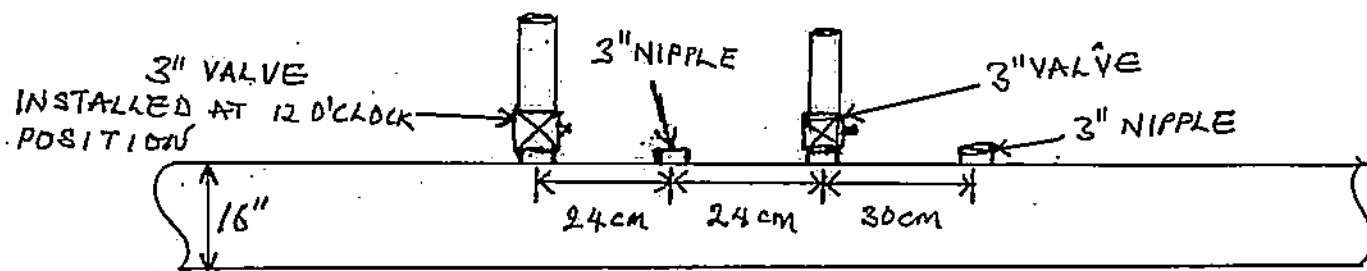
Additional observations around the spill point: THE JOINT INVESTIGATIONS TEAM SAW FOUR (4) ILLEGAL CONNECTIONS, INSTALLED AT 12 O' CLOCK POSITION. 2 NOS 3" VALVES AND 2 NOS 3" NIPPLES

| <input checked="" type="checkbox"/> Crude oil theft (illegal bunkering) point | <input type="checkbox"/> Saver-pit over flow | <input type="checkbox"/> Third party tampering with Clamp |

A SECTION OF 16" EGBEMA-ASSA PIPELINE AT UMUDIKE, SHOWING FOUR (4) 3" CRUDE THEFT FITTINGS, INSTALLED AT 12 O'CLOCK POSITIONS, 24CM AND 30CM FROM EACH, BY UNKNOWN PERSONS

OIL SPILL RESPONSE AND LEAK REPAIR BY CLAMPING.
