JOINT INVESTIGATION REPORT

INCIDENT NO: 2175346 JIV report S/N: 0155

1. Spill incident Number: 2175346 2. Type of incident*: OIL SPILL/FIRE
3. Name of Location 12" IMO RIVER - OGALE PIPELINE
OKPA/
4. Name of nearest community UMUAKPA HU 5. State: RIVERS 6. LGA ELEME
7. Type of Production facility/Installation OIL PIPELINE
8. Asset owner/District THE SHELL PETROLEUM DEVELOPMENT COMPANY OF NIGERIA LTD
(SPDC)/PIPELINE

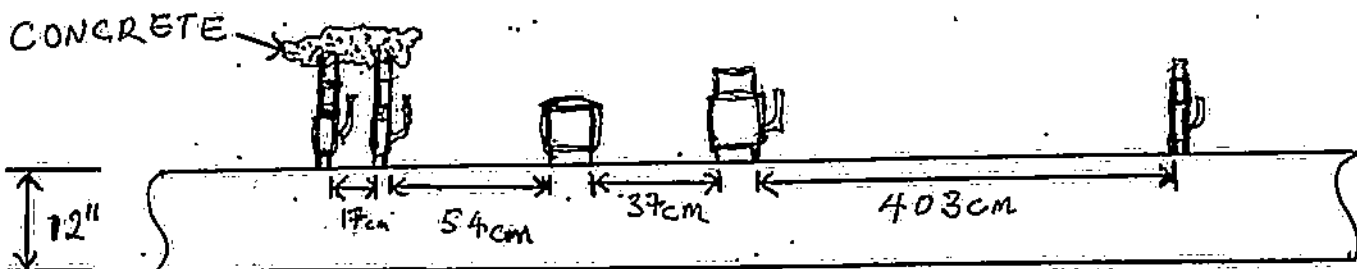
- ① THE SPILL POINT WAS BURNT BY FIRE
② 1" VALVE WAS FOUND 4.03cm AWAY FROM SPILL POINT, IT WAS NON-LEAKING AND INSTALLED AT 12 O'CLOCK POSITION

E. GRAPHIC DESCRIPTION OF LEAK POINT (while detailed report of the leak point should be contained in the leak report, overview sketch of the site should be added as an appendix 1) A SECTION OF 12" IMD RIVER - OGAE PIPELINE AT OKPA/UMUAKPAHU SHOWING 2 NOS OF 3" CRUDE THEFT VALVES AND 3 NOS 1" VALVES. INSTALLED AT 12 O'CLOCK POSITIONS AT GIVEN INTER DISTANCE FROM EACH AS SHOWN BELOW, BY UNKNOWN PERSONS.

REPAIR BY CLAMPING
