# JOINT INVESTIGATION REPORT

INCIDENT NO: 2190827 JIV report S/N: 0167

- 1. Spill incident Number: 2190827      2. Type of incident\*: OIL SPILL
- 3. Name of Location: IMD RIVER 1 WELL 37 FLOWLINE
- 4. Name of nearest community: IGIRIUKWU (ONAZA)      5. State: ABIA      6. LGA: UKWA WEST
- 7. Type of Production facility/Installation: FLOWLINE
- 8. Asset owner/District: THE SHELL PETROLEUM DEVELOPMENT COMPANY OF NIGERIA LIMITED (SPDC) / HANO EAST HUB

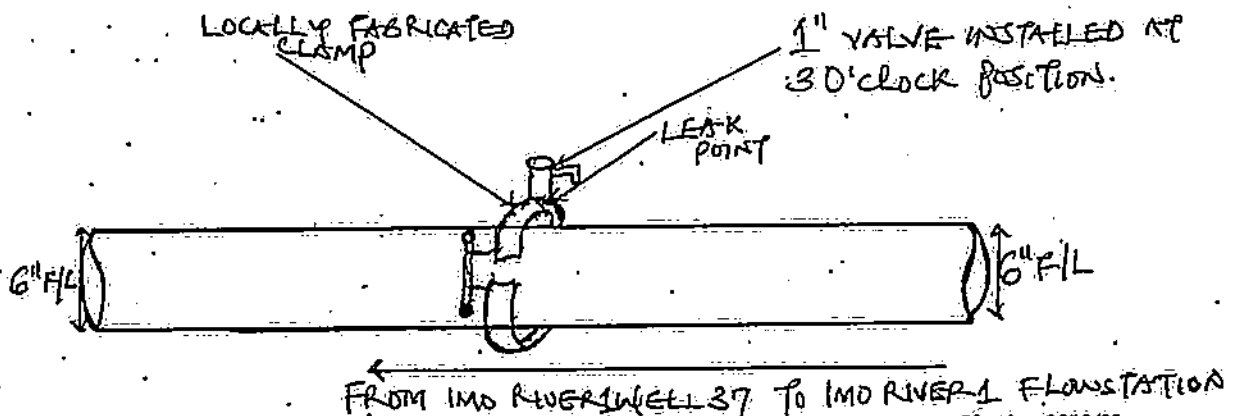
Additional observations around the spill point: SANDSACK CONCEALING CRUDE OIL THEFT POINT WAS OBSERVED.

| <input checked="" type="checkbox"/> Crude oil theft (illegal bunkering) point | <input type="checkbox"/> Saver-pit over flow | <input type="checkbox"/> Third party tampering with Clamp |

SECTION OF IMO RIVER WELL 37 FLOWLINE SHOWING THE POSITION OF A ONE (1") WELT VALVE INSTALLED AT 3 O'CLOCK POSITION WITH A LOCALLY FABRICATED CLAMP BY UNKNOWN PERSONS AT GIRIKWU (ONAZA).
