JOINT INVESTIGATION REPORT

INCIDENT NO: 2193130 JIV report S/N: 0161

1. Spill incident Number: 2193130 2. Type of incident* OIL SPILL
3. Name of Location 24" BOMU - BONNY TRANS NIGER PIPELINE
4. Name of nearest community PATRICK WATER SIDE 5. State: RIVERS 6. LGA GOKANA
7. Type of Production facility/Installation OIL PIPELINE
8. Asset owner/District THE SHELL PETROLEUM DEVELOPMENT COMPANY OF NIGERIA LIMITED / PIPELINE

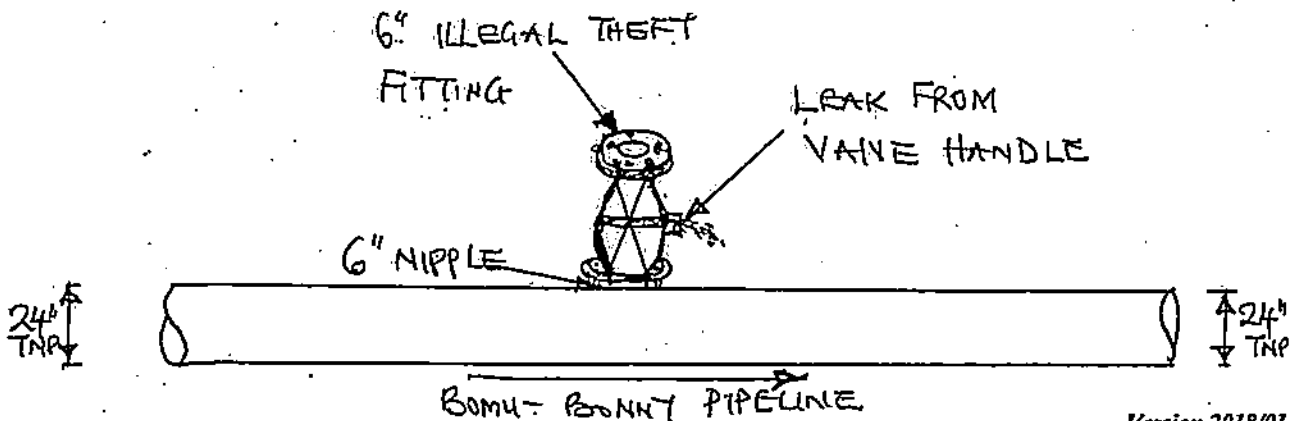
E. GRAPHIC DESCRIPTION OF LEAK POINT (while detailed report of the leak point should be contained in the leak report, overview sketch of the site should be added as an appendix 1)

| <input checked="" type="checkbox"/> Failed Weld-on illegal hot tap valve | <input type="checkbox"/> Failed Clamp | <input type="checkbox"/> Missing Pipeline/Flowline |
| <input checked="" type="checkbox"/> Crude oil theft (illegal bunkering) point | <input type="checkbox"/> Saver-pit over flow | <input type="checkbox"/> Third party tampering with Clamp |

SECTIONAL VIEW OF 24" BOMU - BONNY TRANS NIGER PIPELINE
SHOWING: FAILED 6" BALL VALVE FLANGE ILLEGALLY INSTALLED
AT 12 O'CLOCK POSITION ON THE 24" BOMU - BONNY TNP.

RECOVERY WORK AND REPAIR WORK BY CLAMPING ON-GOING AND WAS LATER COMPLETED.

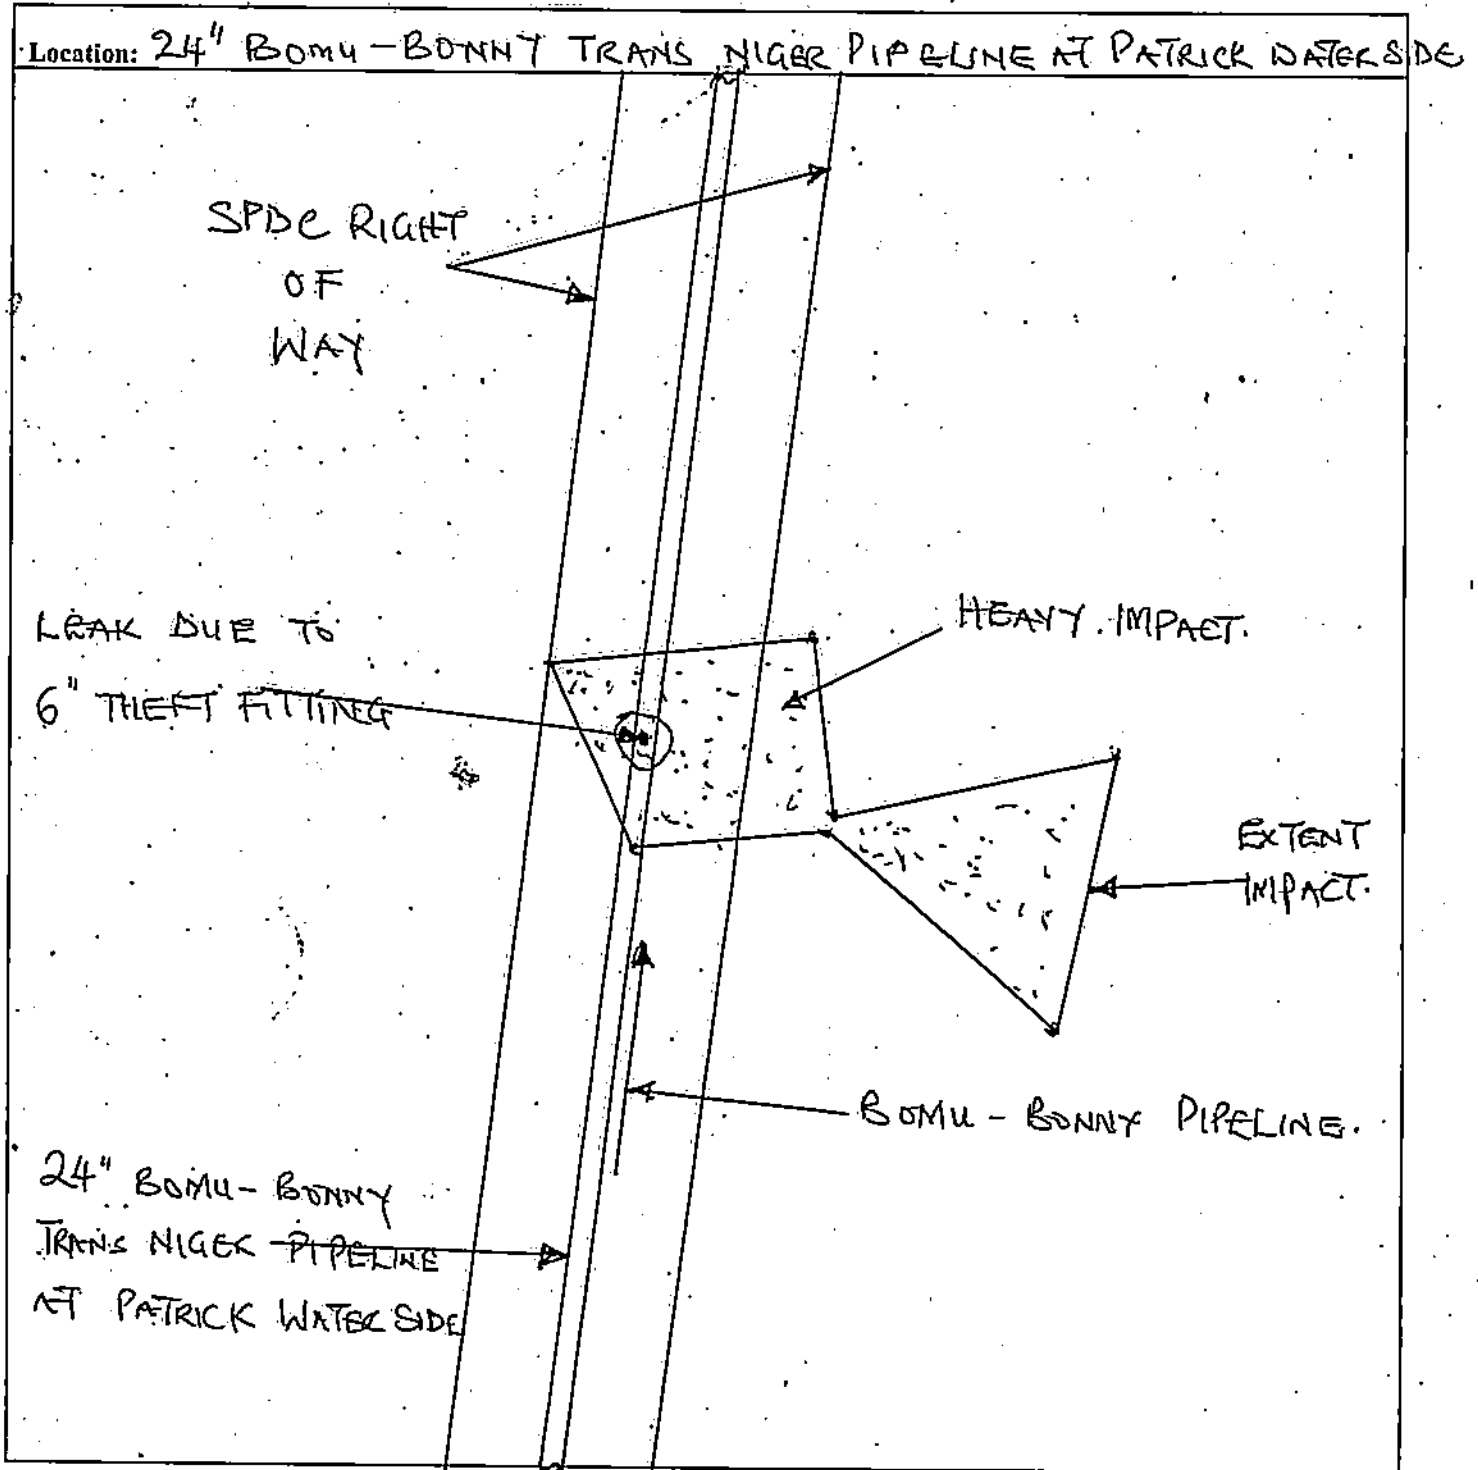
f) Appendix 1: Overview sketch of the site

- Total calculated area of impact 0.18 Ha
- Impact within R.O.W YES
- Impact outside R.O.W YES
