# JOINT INVESTIGATION REPORT

INCIDENT NO: 2154925 JIV report S/N: 0088

1. Spill incident Number: 2154925 2. Type of incident\*: OIL SPILL  
3. Name of Location 24" NKPOKU - BOMU PIPELINE  
4. Name of nearest community BERA 5. State: RIVERS 6. LGA GOKANA  
7. Type of Production facility/Installation OIL PIPELINE  
8. Asset owner/District THE SHELL PETROLEUM DEVELOPMENT COMPANY OF NIGERIA LIMITED PIPELINE

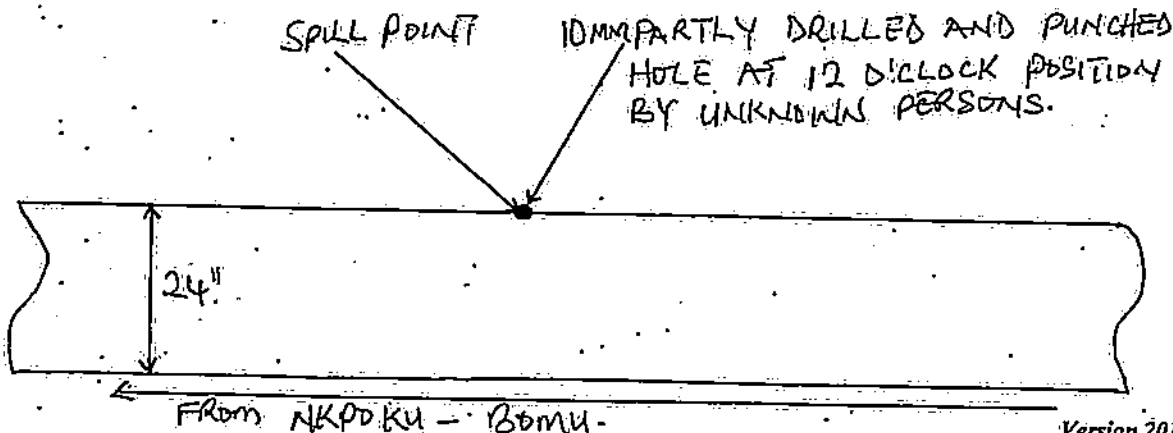
Additional observations around the spill point: THE JOINT INVESTIGATION TEAM OBSERVED 10MM PARTLY DRILLED AND PARTLY PUNCHED HOLE AT 12 O'CLOCK POSITION BY UNKNOWN PERSONS). THE TEAM ALSO OBSERVED BURST SOIL WITHIN THE LEAK POINT AREA.

**E. GRAPHIC DESCRIPTION OF LEAK POINT** (while detailed report of the leak point should be contained in the leak report, overview sketch of the site should be added as an appendix) 1) A SECTION OF 24" NKPOKU-BOMU PIPELINE AT BERA SHOWING A PARTLY DRILLED AND PARTLY PUNCHED HOLE AT 12 O'CLOCK POSITION BY UNKNOWN PERSONS.

CRUDE OIL RECOVERY AND PIPELINE REPAIR BY CLAMPING ARE ONGOING.
