JOINT INVESTIGATION REPORT

INCIDENT NO: 2158908 JIV report S/N: 0043

1. Spill incident Number: 2158908 2. Type of incident*: OIL SPILL
3. Name of Location: 36th NKPOKU - BOMU PIPELINE
4. Name of nearest community: AKIMUESARA (ENEKA) 5. State: RIVERS 6. LGA: OBIO AKPOR
7. Type of Production facility/Installation: OIL PIPELINE
8. Asset owner/District: THE SHELL PETROLEUM DEVELOPMENT COMPANY OF NIGERIA LIMITED / PIPELINE

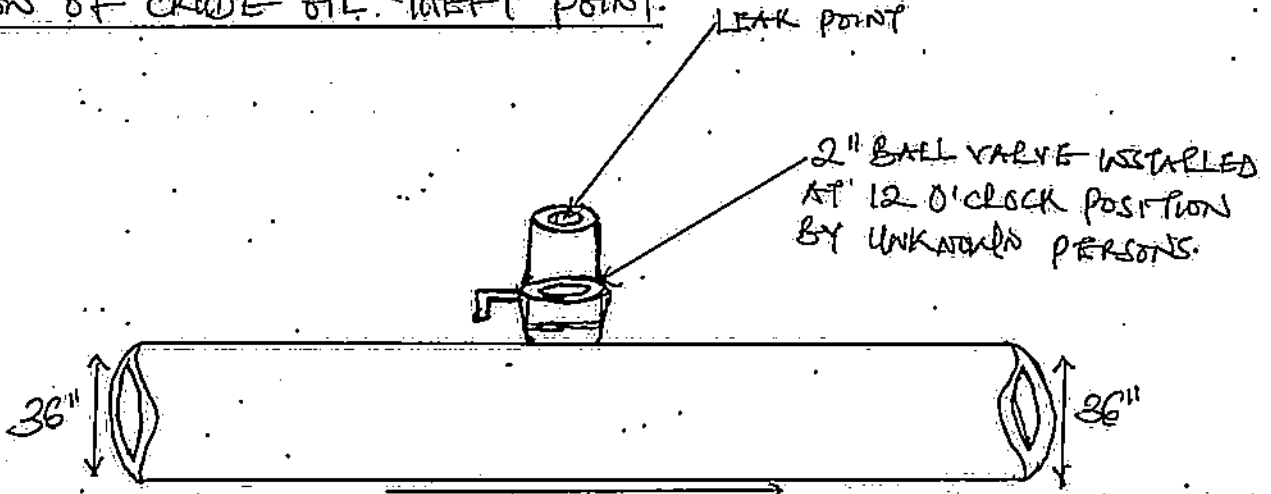
SECTION OF 36" NKPOKY - BOMU PIPELINE AT RUMECARA (ENEKA) SHOWING POSITION OF CRUDE OIL LEAK POINT.

Additional observations around the spill point: SANDBAGS CONCEALING CRUDE OIL THEFT POINT WAS OBSERVED

| <input checked="" type="checkbox"/> Failed Weld-on illegal hot tap valve | <input type="checkbox"/> Failed Clamp | <input type="checkbox"/> Missing Pipeline/Flowline |
| <input checked="" type="checkbox"/> Crude oil theft (illegal bunkering) point | <input type="checkbox"/> Saver-pit over flow | <input type="checkbox"/> Third party tampering with Clamp |

RECOVERY AND REPAIR ACTIVITIES ARE ONGOING
