JOINT INVESTIGATION REPORT

INCIDENT NO: 215 74 30 JIV report S/N: 0092

1. Spill incident Number: 215 74 30 2. Type of incident*: OIL SPILL
3. Name of Location 14th DKORDEA - KUMUEKPE PIPELINE
4. Name of nearest community AKARAMINI 5. State: RIVERS 6. LGA AHOADA WEST
7. Type of Production facility/Installation OIL PIPELINE
8. Asset owner/District THE SHELL PETROLEUM DEVELOPMENT COMPANY OF NIGERIA LIMITED PIPELINE

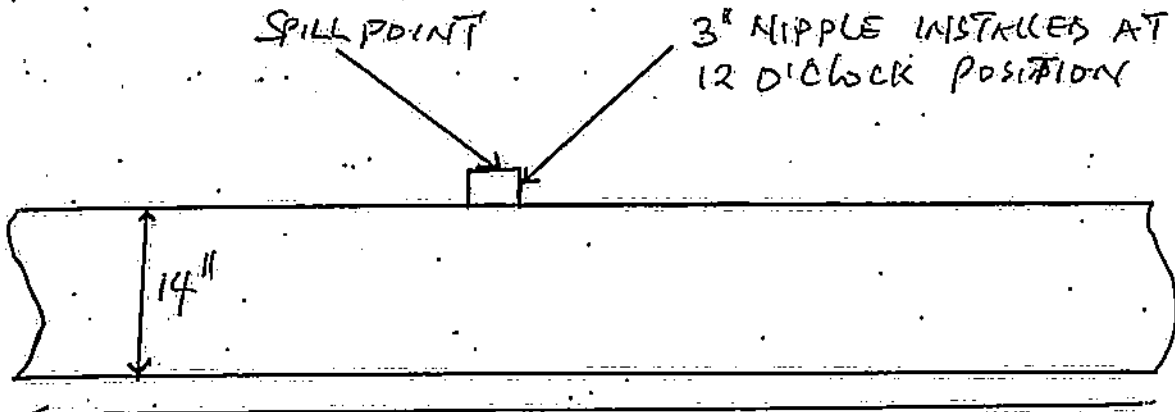
Additional observations around the spill point: THE JOINT INVESTIGATION TEAM OBSERVED 3" NIPPLE INSTALLED AT 12 O'CLOCK POSITION BY UNKNOWN PERSON(S).

E. GRAPHIC DESCRIPTION OF LEAK POINT (while detailed report of the leak point should be contained in the leak report, overview sketch of the site should be added as an appendix 1) A SECTION OF 14" DIAMETER RUMUKPE PIPELINE AT AKARAMINI SHOWING 3" NIPPLE INSTALLED AT 12 O'CLOCK POSITION BY UNKNOWN PERSON(S).

CRUDE OIL RECOVERY AND REPAIR BY CLAMPING
ARE ON GOING.

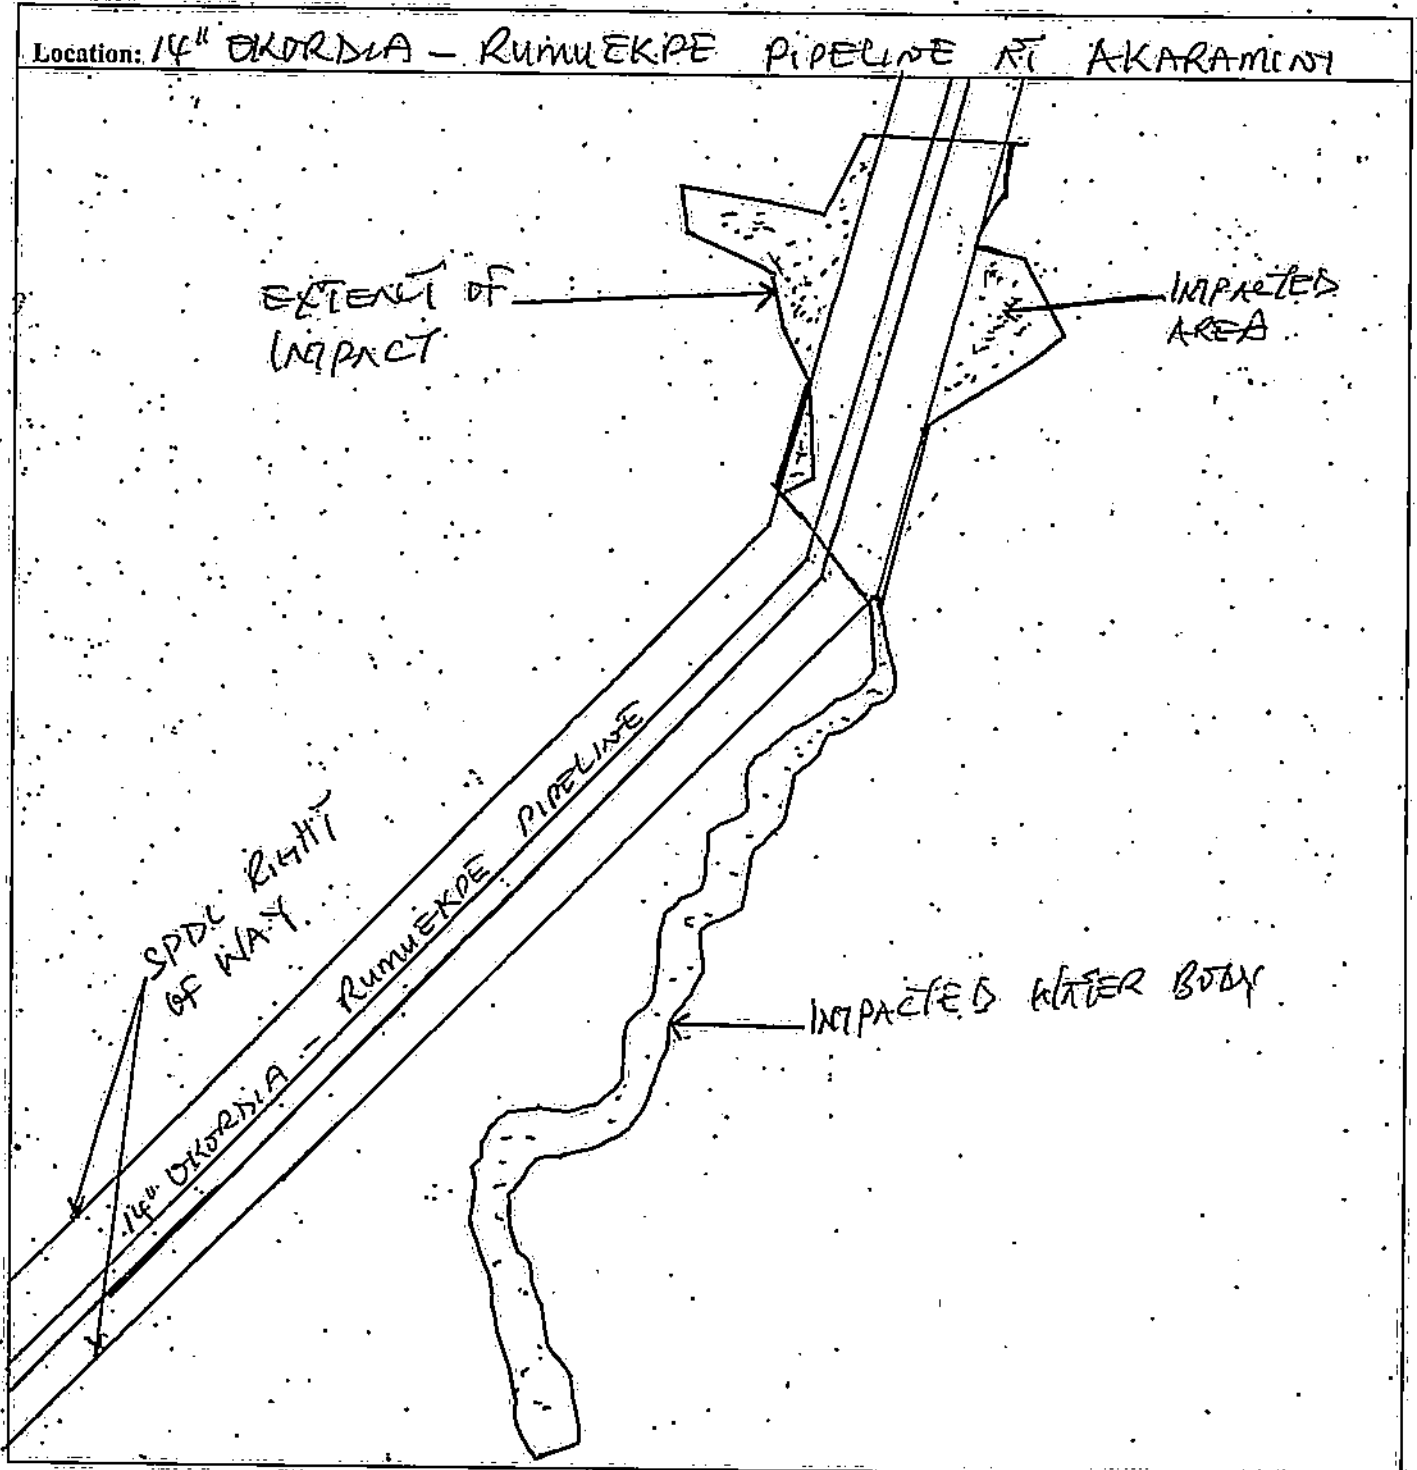
f. Appendix 1: Overview sketch of the site

- Total calculated area of impact 2.933 HA
- Impact within R.O.W. YES
- Impact outside R.O.W. YES
