JOINT INVESTIGATION REPORT

INCIDENT NO: 2158670 JIV report S/N: 1143

1. Spill incident Number: 2158670 2. Type of incident* OIL SPILL
3. Name of Location 20" OTUMARA - ESCRAVOS PIPELINE
4. Name of nearest community IGBOEGUNGUM 5. State: DELTA 6. LGA WARRI SOUTH - WEST
7. Type of Production facility/installation OIL PIPELINE
8. Asset owner/District THE SHELL PETROLEUM DEVELOPMENT COMPANY OF NIGERIA LIMITED / PIPELINE

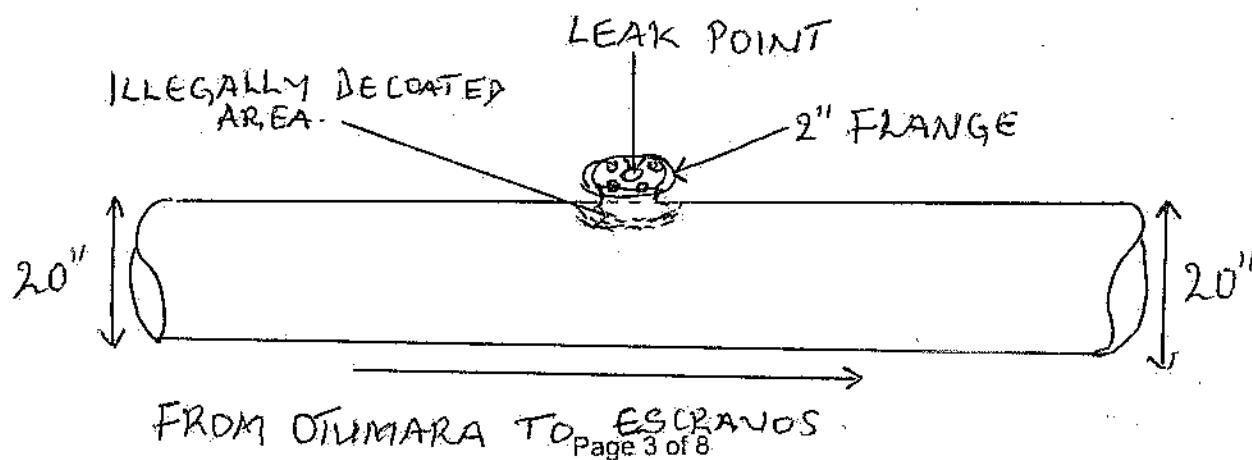
Additional observations around the spill point: 2" FLANGE ILLEGALLY ATTACHED TO THE 20" OTUMARA - ESCRAVOS PIPELINE AT 12 O'CLOCK POSITION WAS OBSERVED BY THE JOINT INVESTIGATION TEAM.

| <input checked="" type="checkbox"/> Failed Weld-on illegal hot tap valve | <input type="checkbox"/> Failed Clamp, | <input type="checkbox"/> Missing Pipeline/Flowline |
| <input checked="" type="checkbox"/> Crude oil theft (illegal bunkering) point, | <input type="checkbox"/> Saver-pit over flow | <input type="checkbox"/> Third party tampering with Clamp |

SECTION OF 20" OTUMARA - ESCRANOS PIPELINE AT UGBOEGUNGUN
SHOWING CRUDE OIL THEFT POINT AT 12 O'CLOCK POSITION
