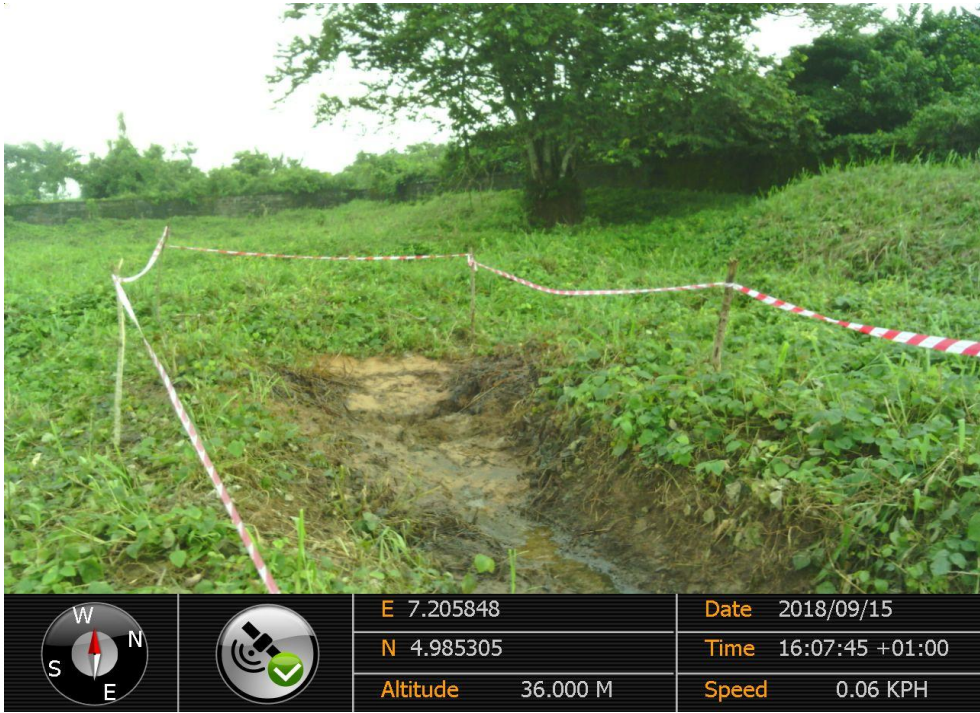
Overview: Part of spill impact on Imo River Well 59T Flowline at Igiriukwu-Owaza. Picture was taken during Joint Investigation of 15th September 2018.

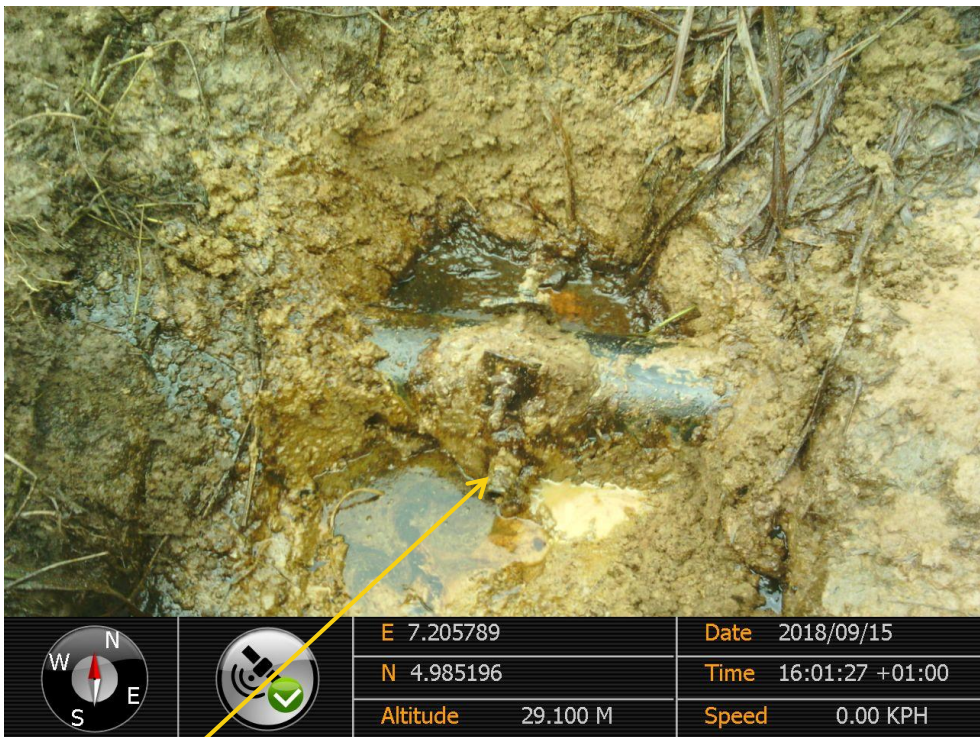
Close-up: Illegal fitting on Imo River Well 59T Flowline at Igiriukwu-Owaza. Picture was taken during Joint Investigation of 15th September 2018.
