JOINT INVESTIGATION REPORT

INCIDENT NO: 2162391 JIV report S/N: 0084

- 1. Spill incident Number: 2162391 2. Type of incident* OIL SPILL
- 3. Name of Location 16" EGBENIA - ASSA (TRUNKLINE) PIPELINE
- 4. Name of nearest community ASSA 5. State: IMO 6. LGA OTAJI EGBEMA
- 7. Type of Production facility/Installation OIL PIPELINE
- 8. Asset owner/District THE SHELL PETROLEUM DEVELOPMENT COMPANY OF NIGERIA LIMITED PIPELINE

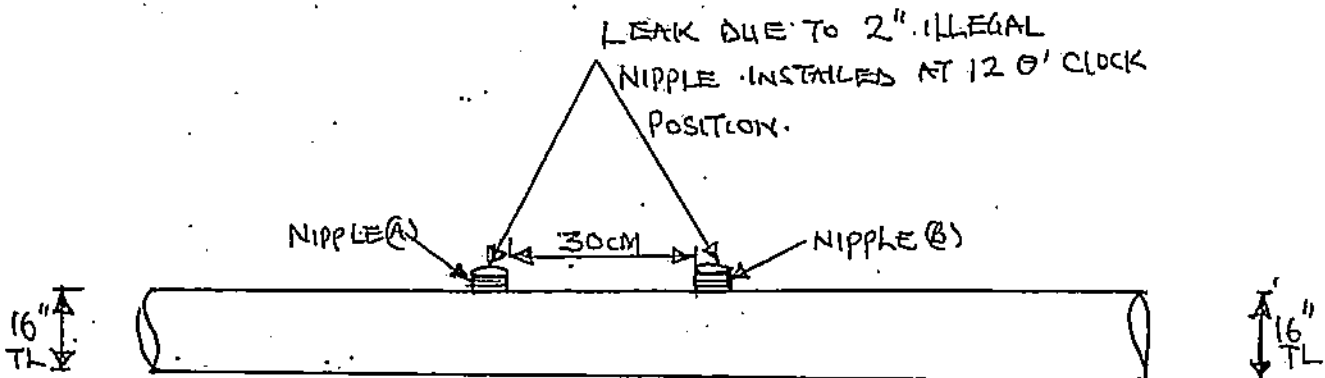
EGBEMA - ASSA PIPELINE

Additional observations around the spill point:
THE JOINT INVESTIGATION TEAM OBSERVED EVIDENCE OF SAND BAGS USED TO CONCEALED THE THEFT POINTS.

| <input checked="" type="checkbox"/> Failed Weld-on illegal hot tap valve | <input type="checkbox"/> Failed Clamp | <input type="checkbox"/> Missing Pipeline/Flowline |
| <input checked="" type="checkbox"/> Crude oil theft (illegal bunkering) point | <input type="checkbox"/> Saver-pit over flow | <input type="checkbox"/> Third party tampering with Clamp |

SECTIONAL VIEW OF 16" EGBEMA - ASSA (TRUNKLINE) PIPELINE AT ASSA SHOWING: - TWO (2) NO OF 2" ILLEGAL NIPPLE INSTALLED AT 12 O' CLOCK POSITION BY UNKNOWN PERSON (S)

RECOVERY WORK AND REPAIR WORK BY CLAMPING COMMENCE
AND ARE ON - GOING.
