# JOINT INVESTIGATION REPORT

INCIDENT NO: 2161789 JIV report S/N: 0095

1. Spill incident Number: 2161789 2. Type of incident\* OIL SPILL  
3. Name of Location 6" OBIGBO NORTH - OGALE (DELIVERYLINE) PIPELINE  
4. Name of nearest community OGALE 5. State: RIVERS 6. LGA ELEME  
7. Type of Production facility/Installation OIL PIPELINE  
8. Asset owner/District THE SHELL PETROLEUM DEVELOPMENT COMPANY OF NIGERIA LIMITED | PIPELINE

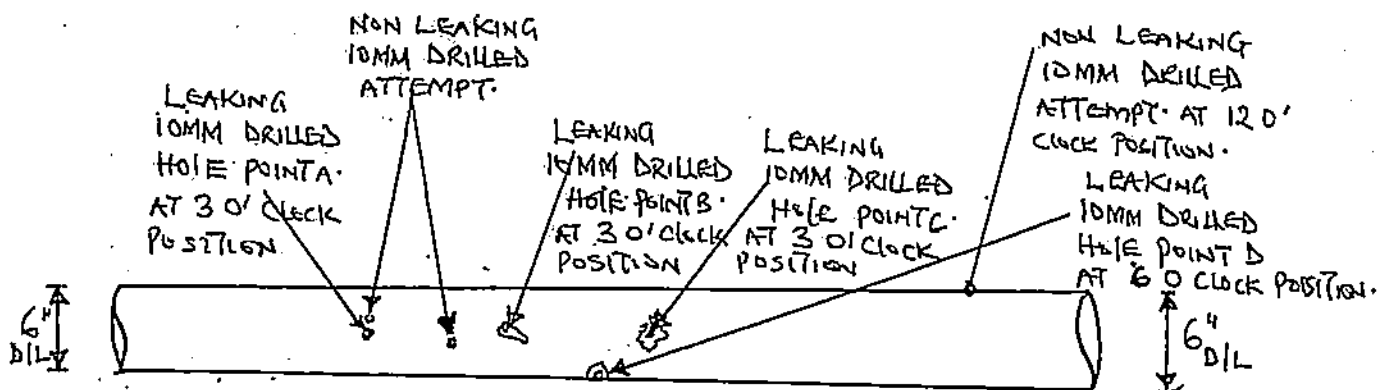
ØBIGBO NORTH - ØGALE PIPELINE.

| <input checked="" type="checkbox"/> Drilled hole | <input type="checkbox"/> Hack saw cut | <input type="checkbox"/> Tear (_____) |

- Third party interference (Sabotage; crude theft; Line theft; Accidental 3<sup>rd</sup> party damage  
 Operational  Mystery spills  Others(specify) \_\_\_\_\_

SECTIONAL VIEW OF 6" ØBIGBO NORTH - ØGALE (DELIVERY LINE) PIPELINE AT ØGALE SHOWING:- MULTIPLE DRILLED HOLES AT DEFERENT POINTS.

RECOVERY WORK AND REPAIR WORK BY CLAMPING ARE ON -  
GOING.
