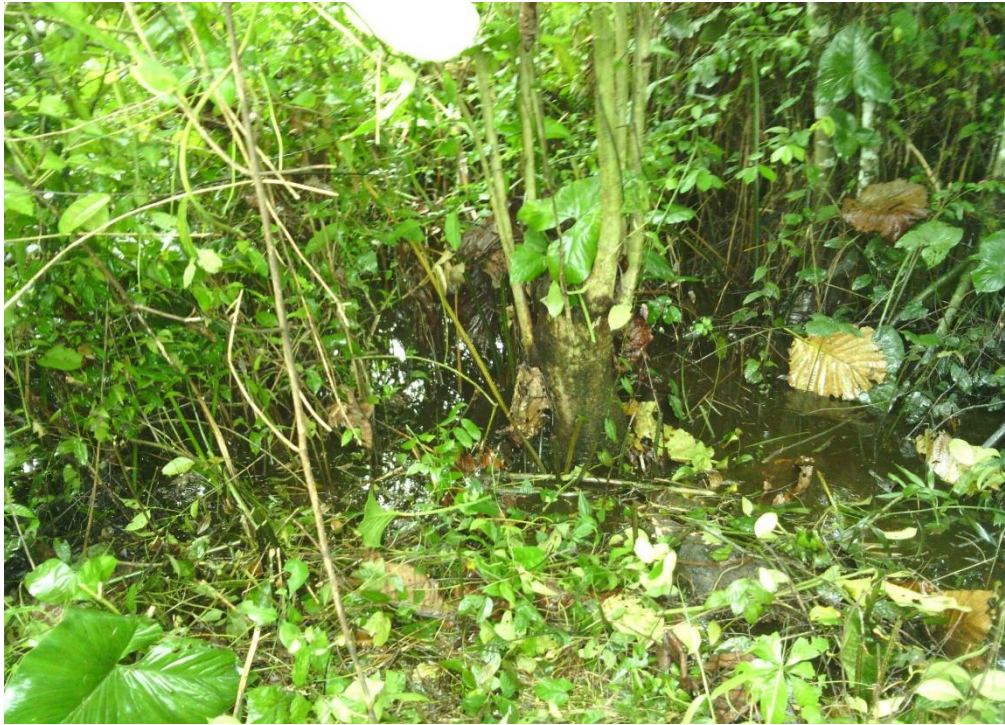
Overview: Part of spill impact on Imo River–Well 31L Flowline at Odagwa-Umuadeokwara.
Picture was taken during Joint Investigation of 6th September 2018.

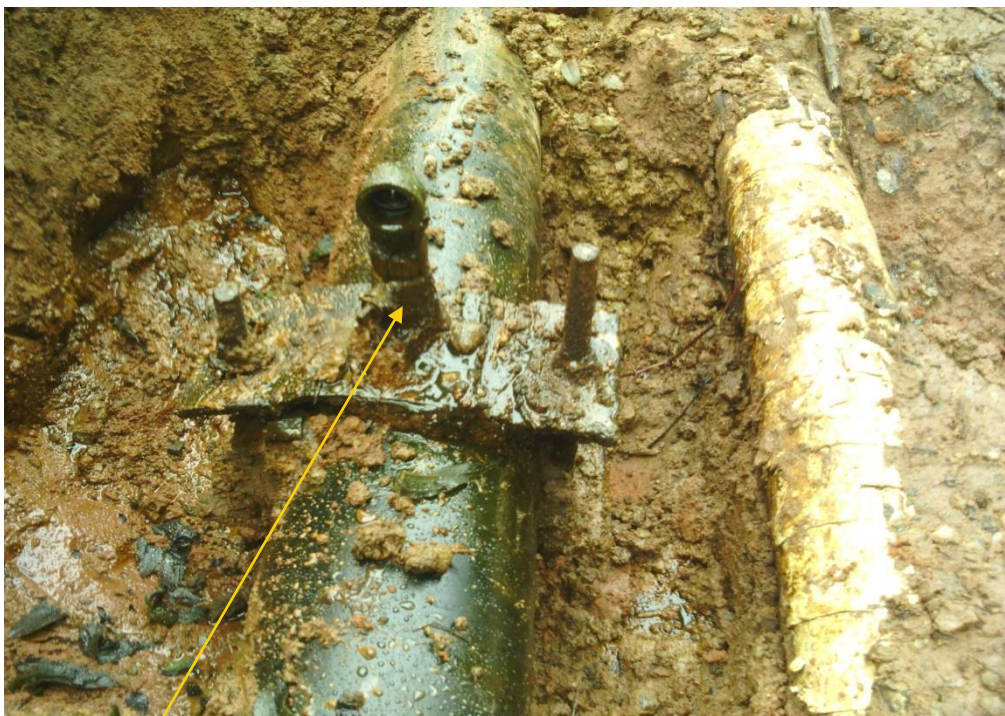
Close up: Illegal fitting on Imo River2 – Well 31L Flowline at Odagwa-Umuadeokwara .
Picture was taken during Joint Investigation of 6th September 2018.
