JOINT INVESTIGATION REPORT

INCIDENT NO: 2168596 JIV report S/N: 0151

1. Spill incident Number: 2168596 2. Type of incident*: OIL SPILL
3. Name of Location 18" ASSA - RUMUEKPE PIPELINE
4. Name of nearest community AKPABU 5. State: RIVERS 6. LGA EMOHIA
7. Type of Production facility/Installation DLK PIPELINE
8. Asset owner/District THE SHELL PETROLEUM DEVELOPMENT COMPANY OF NIGERIA LTD (SPDC) / PIPELINE

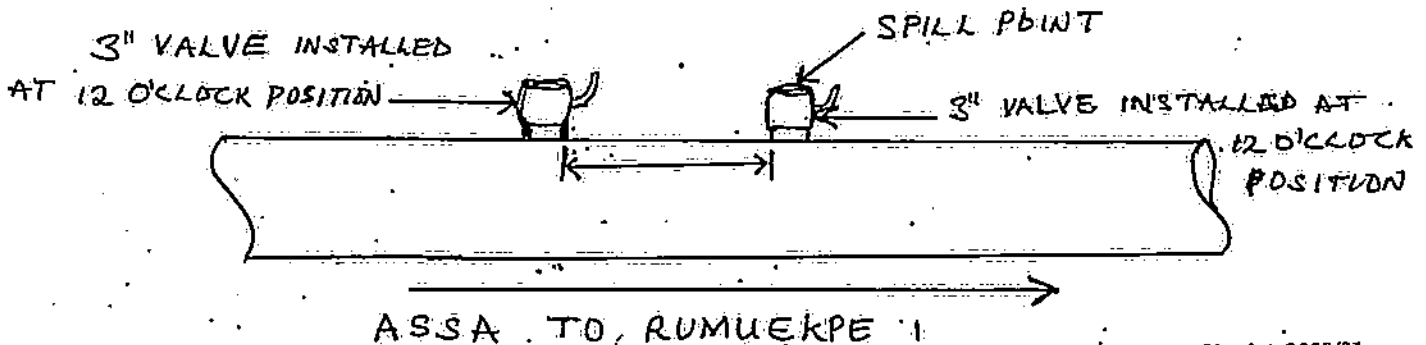
E. GRAPHIC DESCRIPTION OF LEAK POINT (while detailed report of the leak point should be contained in the leak report, overview sketch of the site should be added as an appendix 1) A SECTION OF 18" ASSA - RUMUEKPE PIPELINE AT AKPABU SHOWING 2 NO. 3" VALVE CRUDE THEFT POINT INSTALLED APART AT 12 O'CLOCK POSITION BY UNKNOWN PERSONS
