JOINT INVESTIGATION REPORT

INCIDENT NO: 2171188 JIV report S/N: 0042

1. Spill incident Number: 2171188 2. Type of incident*: OIL SPILL
3. Name of Location: 20" KOLOCREEK - RUMUEKPE PIPELINE
4. Name of nearest community: ODAU 5. State: RIVERS 6. LGA: ABUA/ODUA
7. Type of Production facility/Installation: OIL PIPELINE
8. Asset owner/District: THE SHELL PETROLEUM DEVELOPMENT COMPANY OF NIGERIA LTD (SPDC) / PIPELINE

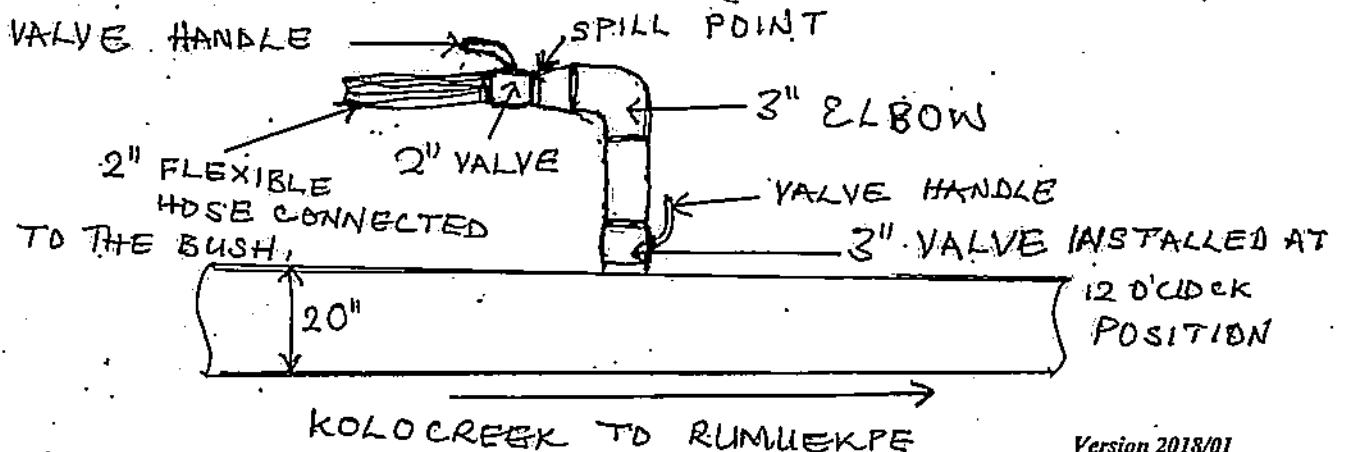
Additional observations around the spill point: THE JOINT INVESTIGATION TEAM SAW A 3" VALVE CONNECTED AT 12 O'CLOCK POSITION AND AN ELBOW CONNECTION TO THE VALVE.

| <input checked="" type="checkbox"/> Crude oil theft (illegal bunkering) point | <input type="checkbox"/> Saver-pit over flow | <input type="checkbox"/> Third party tampering with Clamp |

E. GRAPHIC DESCRIPTION OF LEAK POINT (while detailed report of the leak point should be contained in the leak report, overview sketch of the site should be added as an appendix 1) A SECTION OF 20" KOLOCREEK - RUMUEKPE PIPELINE AT ODAU SHOWING 3" VALVE CRUDE THEFT POINT INSTALLED AT 12 O'CLOCK POSITION BY UNKNOWN PERSONS

CEMENT GROUTING
