JOINT INVESTIGATION REPORT

INCIDENT NO: 2319360 JIV report S/N: 0262

1. Spill incident Number: 2319360 2. Type of incident* OIL SPILL
3. Name of Location 12" MD. RIVER 2 - OGALE PIPELINE
4. Name of nearest community IGIRUKWU SWAZA 5. State: ABIA 6. LGA UKWA - WEST
7. Type of Production facility/Installation OIL PIPELINE
8. Asset owner/District THE SHELL PETROLEUM DEVELOPMENT COMPANY OF NIGERIA LIMITED/PIPELINE

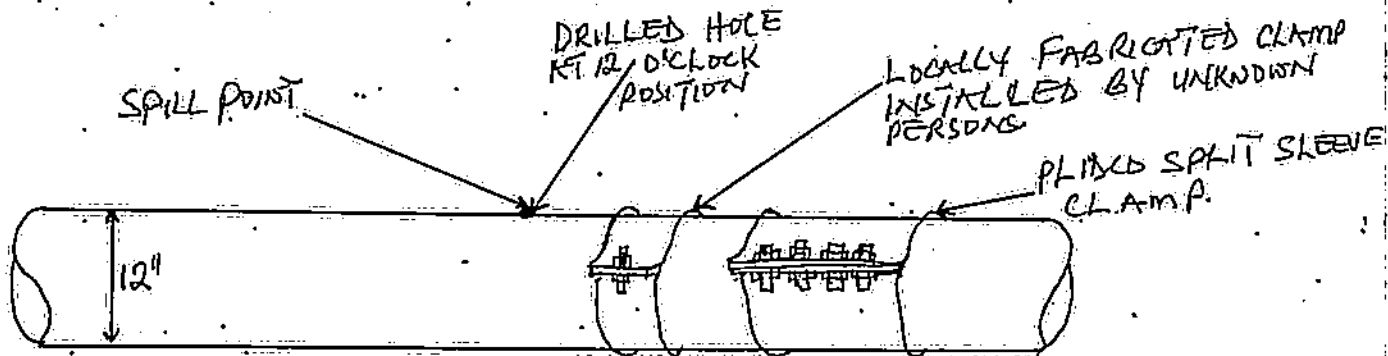
| <input checked="" type="checkbox"/> Drilled hole | <input type="checkbox"/> Hack saw cut | <input type="checkbox"/> Tear (_____) |
| <input checked="" type="checkbox"/> Crude oil theft (illegal bunkering) point | <input type="checkbox"/> Saver-pit over flow | <input type="checkbox"/> Third party tampering with Clamp |

RIVER 2 - OGALE PIPELINE AT IGIRIUKWU-DWAZA SHOWING A DRILLED HOLE AT 12 O'CLOCK POSITION AND A LOCALLY FABRICATED CLAMP INSTALLED BY UNKNOWN PERSONS.

CRUDE OIL RECOVERY AND REPAIR ACTIVITIES ARE ONGOING.
