JOINT INVESTIGATION REPORT

INCIDENT NO: 2319363 JIV report S/N:0287

1. Spill incident Number: 2319363 2. Type of incident* OIL SPILL
3. Name of Location 12" INCH RNER 2 - OGALLE PIPELINE
4. Name of nearest community OWAZA 5. State: ABIA 6. LGA UKWUA-KEST
7. Type of Production facility/Installation OIL PIPELINE
8. Asset owner/District THE SHELL PETROLEUM DEVELOPMENT COMPANY OF NIGERIA
LIMITED PIPELINE.

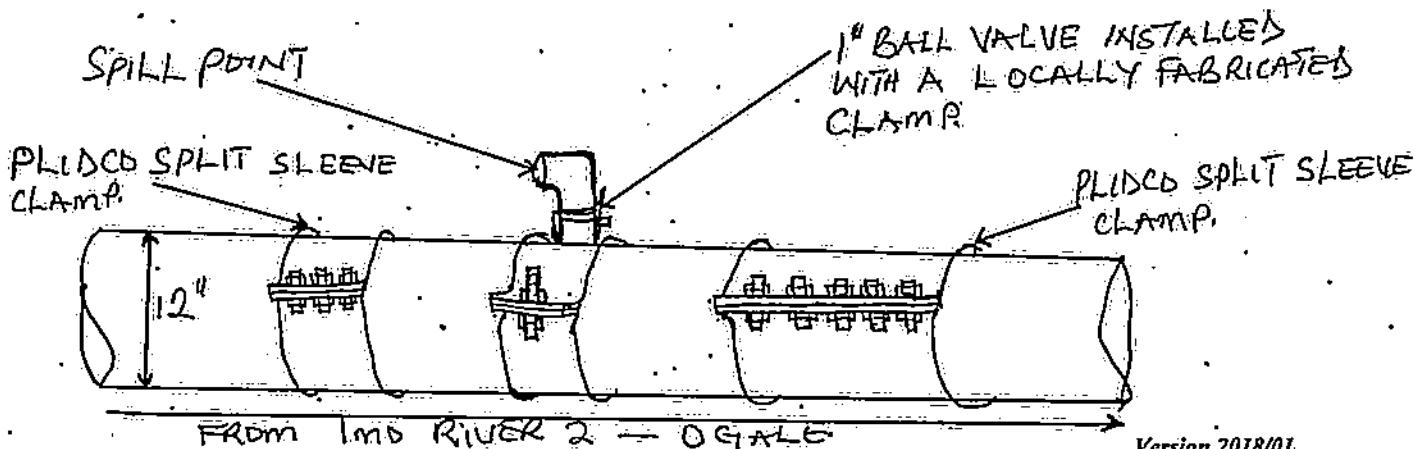
E. GRAPHIC DESCRIPTION OF LEAK POINT (while detailed report of the leak point should be contained in the leak report, overview sketch of the site should be added as an appendix I) A SECTION OF 12" IMB RIVER 2 - OGATE PIPELINE AT IGIRIUKWU - OWAZA SHOWING A ONE(1)" VALVE WITH A LOCALLY FABRICATED CLAMP INSTALLED AT 12 O'CLOCK POSITION BY UNKNOWN PERSONS.

CRUISE OIL RECOVERY AND REPAIR ACTIVITIES ARE
ONGOING.
