# JOINT INVESTIGATION REPORT

INCIDENT NO: 2314360 JIV report S/N: 0232

1. Spill incident Number: 2314360 2. Type of incident\*: OIL SPILL  
3. Name of Location 16" NUN RIVER - KOLO CREEK PIPELINE  
4. Name of nearest community OTUEGWE 1 5. State: BAYELSA 6. LGA OGBIA  
7. Type of Production facility/Installation OIL PIPELINE  
8. Asset owner/District THE SHELL PETROLEUM DEVELOPMENT COMPANY OF NIGERIA LTD (SPDC) / PIPELINE

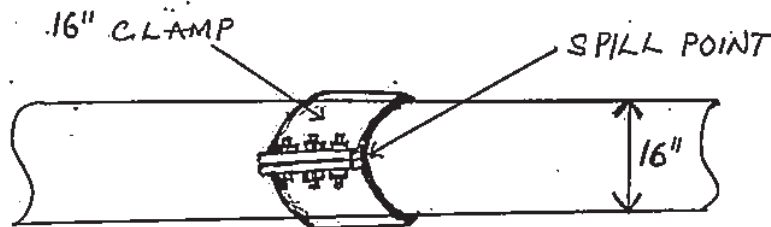
| <input type="checkbox"/> Failed Weld-on illegal hot tap valve | <input checked="" type="checkbox"/> Failed Clamp | <input type="checkbox"/> Missing Pipeline/Flowline |

**E. GRAPHIC DESCRIPTION OF LEAK POINT** (while detailed report of the leak point should be contained in the leak report, overview sketch of the site should be added as an appendix 1) A SECTION OF 16"

NUN RIVER - KOLOCREEK PIPELINE AT OTUEGWE I SHOWING FAILED CLAMP.

CLAMP REPLACEMENT
