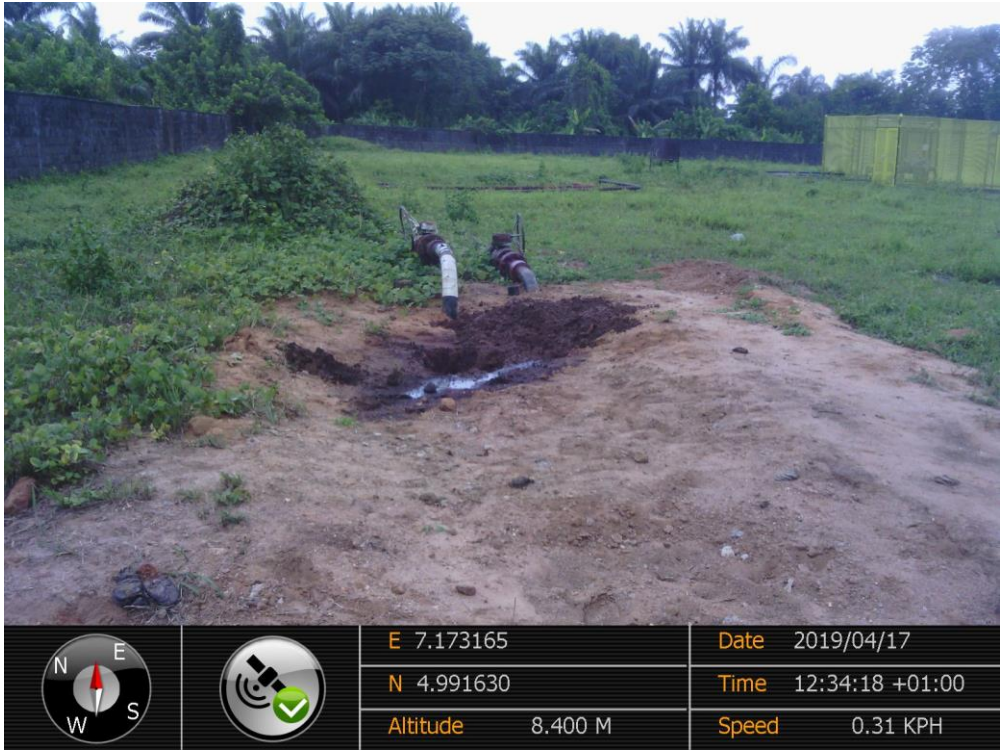
Overview: Part of spill impact on 4" Imo River2 Well 21L Flowline at Odagwa. Picture was taken during Joint Investigation of 17th April 2019.

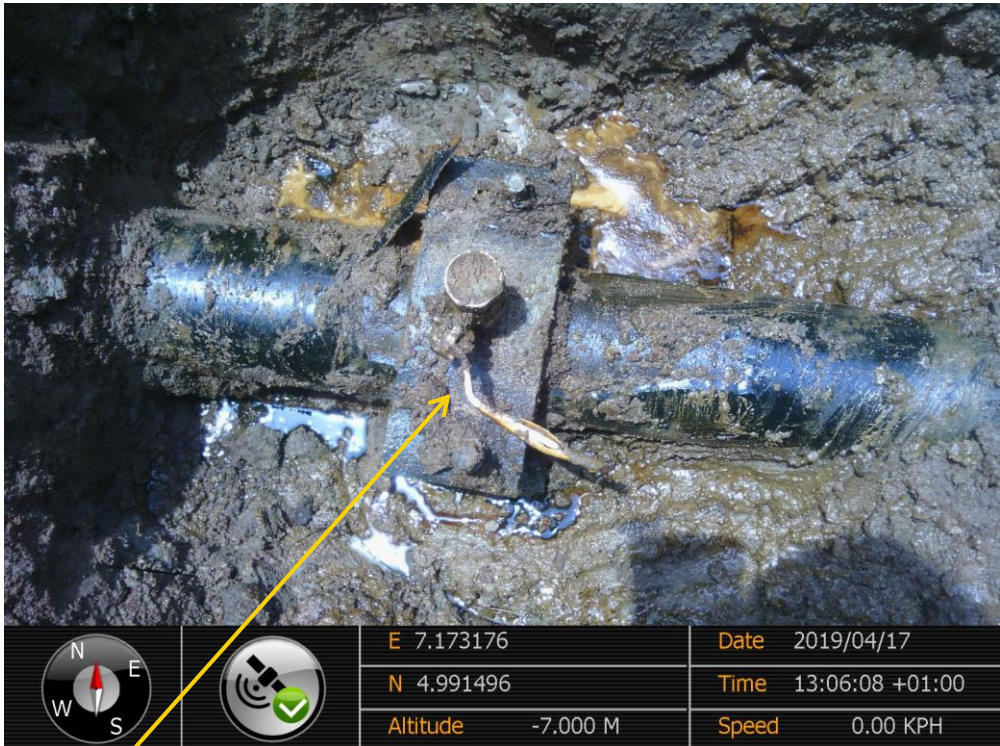
Close-up: Illegal Fitting on 4" Imo River2 Well 21L Flowline at Odagwa. Picture was taken during Joint Investigation of 17th April 2019
