# JOINT INVESTIGATION REPORT

INCIDENT NO: 2324256 JIV report S/N:0269

1. Spill incident Number: 2324256 2. Type of incident\*: OIL SPILL  
3. Name of Location 4" IMO RIVER 2 WELL 21L FLOWLINE  
4. Name of nearest community ODAGWA 5. State: RIVERS 6. LGA ETCHE  
7. Type of Production facility/Installation FLOWLINE  
8. Asset owner/District THE SHELL PETROLEUM DEVELOPMENT COMPANY OF NIGERIA LIMITED / LAND EAST HUB

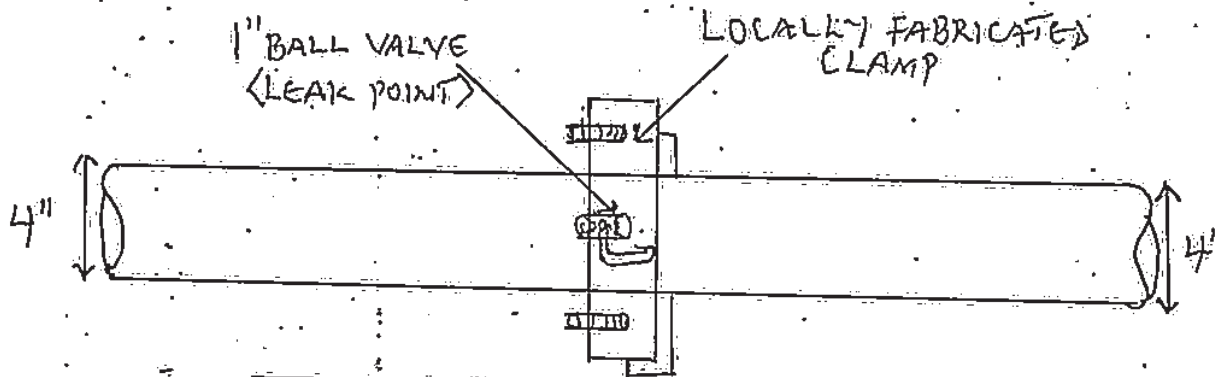
Additional observations around the spill point: THE JOINT INVESTIGATION TEAM OBSERVED LOCALLY FABRICATED CLAMP WITH 1" BALL VALVE, ILLEGALLY ATTACHED TO 4" IMO RIVER 2 WELL 21L FLOWLINE.

| <input checked="" type="checkbox"/> Failed Weld-on illegal hot tap valve | <input type="checkbox"/> Failed Clamp | <input type="checkbox"/> Missing Pipeline/Flowline |
| <input checked="" type="checkbox"/> Crude oil theft (illegal bunkering) point | <input type="checkbox"/> Saver-pit over flow | <input type="checkbox"/> Third party tampering with Clamp |

SECTION OF 4" IMORIVER 2 WELL 21L FLOWLINE AT ODABWA SHOWING CRUDE OIL THEFT POINT AT 12 O'CLOCK POSITION.
