JOINT INVESTIGATION REPORT

INCIDENT NO: 2319057 JIV report S/N: 0170

1. Spill incident Number: 2319057 2. Type of incident*: FIRE/OIL SPILL
3. Name of Location 24" BOMU - BONNY TRANS NLGER PIPELINE
4. Name of nearest community PATRICK WATER SIDE 5. State: RIVERS 6. LGA: GOKANA
7. Type of Production facility/Installation OIL PIPELINE
8. Asset owner/District THE SHELL PETROLEUM DEVELOPMENT COMPANY OF NIGERIA LIMITED PIPELINE

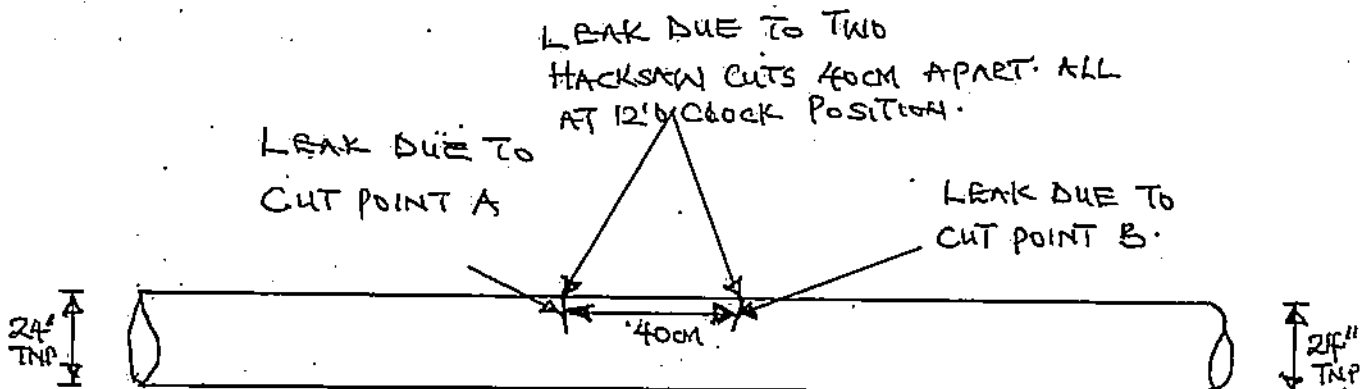
SECTIONAL VIEW OF 24" BOMU - BONNY TRANS NIGER PIPELINE AT PATRICK WATER SIDE. SHOWING: TWO (2) HACKSAW CUTS AT 12'O CLOCK POSITION.

REPAIR BY CLAMPING AND RECOVERY WORK COMPLETED
