# JOINT INVESTIGATION REPORT

INCIDENT NO: 2325757 JIV report S/N: 0263

1. Spill incident Number: 2325757 2. Type of incident\*: OIL SPILL  
3. Name of Location 16" ASSA - RUMUEKPE PIPELINE  
4. Name of nearest community OLHIA - ANARRA 5. State: IMO 6. LGA OHAJI / EGBAMA  
7. Type of Production facility/Installation OIL PIPELINE  
8. Asset owner/District THE SHELL PETROLEUM DEVELOPMENT COMPANY OF NIGERIA LIMITED (SPDC) / PIPELINE

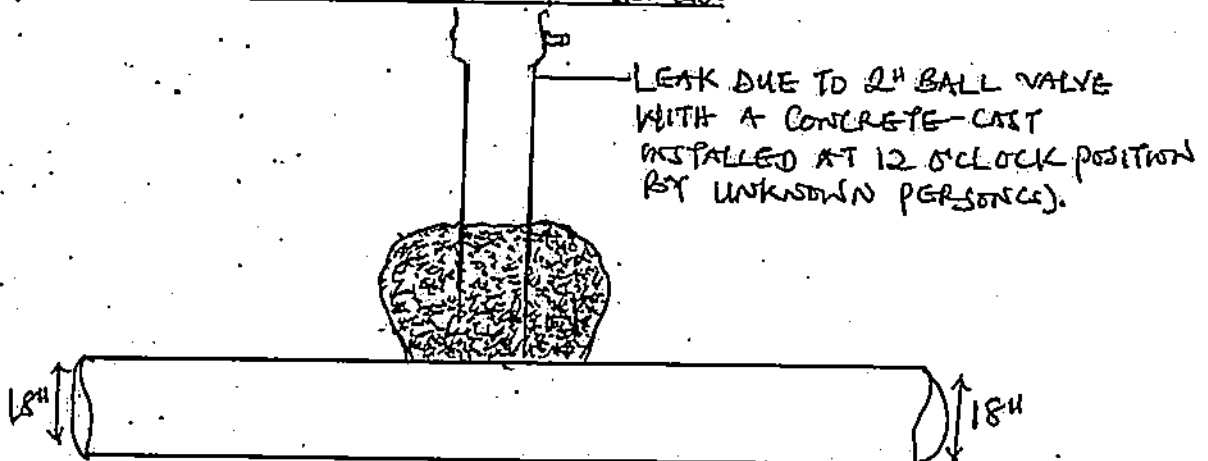
**E. GRAPHIC DESCRIPTION OF LEAK POINT** (while detailed report of the leak point should be contained in the leak report, overview sketch of the site should be added as an appendix 1)

Additional observations around the spill point: SANDBAGS AND CONCRETE-CAST CONCEALING CRUDE OIL THEFT POINT WERE OBSERVED BY THE JOINT INVESTIGATION TEAM.

SECTIONAL VIEW OF 18" ASSA - KUMUKPE PIPELINE AT OCHA - ANAKA  
SHOWING A TWO INCH (2") BALL VALVE WITH A CONCRETE CAST INSTALLED AT  
12 O'CLOCK POSITION BY UNKNOWN PERSON(S).

REPAIR ACTIVITIES ARE ONGOING
