JOINT INVESTIGATION REPORT

INCIDENT NO: 2327455 JIV report S/N: 0299

1. Spill incident Number: 2327455 2. Type of incident*: OIL SPILL
3. Name of Location: 24th NKPOKU - BOMU PIPELINE (TNP)
4. Name of nearest community: FEBALOR 5. State: RIVERS 6. LGA: ELEME
7. Type of Production facility/Installation: OIL PIPELINE
8. Asset owner/District: THE SHELL PETROLEUM DEVELOPMENT COMPANY OF NIGERIA LIMITED/PIPELINE

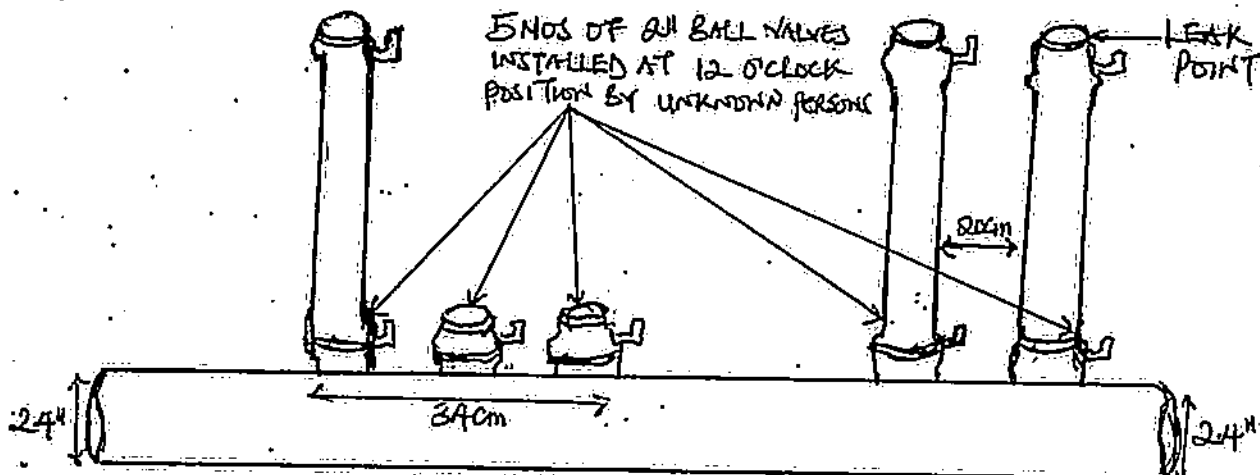
| <input checked="" type="checkbox"/> Failed Weld-on illegal hot tap valve | <input type="checkbox"/> Failed Clamp | <input type="checkbox"/> Missing Pipeline/Flowline |
| <input checked="" type="checkbox"/> Crude oil theft (illegal bunkering) point | <input type="checkbox"/> Saver-pit over flow | <input type="checkbox"/> Third party tampering with Clamp |

A SECTION OF 24" NKPOKU - BOMU PIPELINE AT EGBALOR SHOWING ENDS OF 2" BALL VALVES INSTALLED AT 12 O'CLOCK POSITION BY UNKNOWN PERSONS.

REPAIR ACTIVITIES ARE ONGOING
