JOINT INVESTIGATION REPORT

INCIDENT NO: 2327505 JIV report S/N: 0223

1. Spill incident Number: 2327505 2. Type of incident*: OIL SPILL
3. Name of Location: 12" IMO RIVER - OGALE PIPELINE
4. Name of nearest community: OGALE 5. State: RIVERS 6. LGA: ELEME
7. Type of Production facility/Installation: OIL PIPELINE
8. Asset owner/District: THE SHELL PETROLEUM DEVELOPMENT COMPANY OF NIGERIA LIMITED (SPDC) / PIPELINE

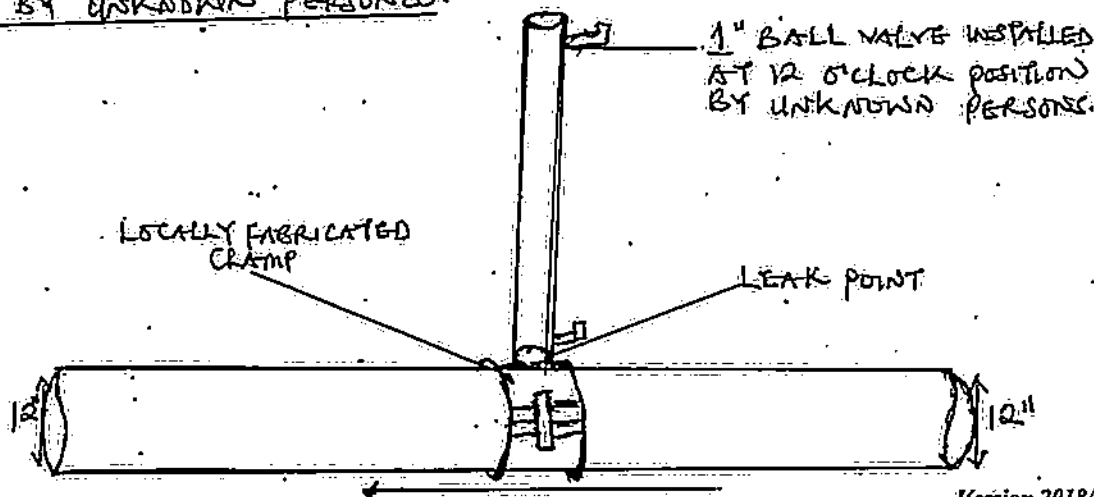
| <input checked="" type="checkbox"/> Failed Weld-on illegal hot tap valve | <input type="checkbox"/> Failed Clamp | <input type="checkbox"/> Missing Pipeline/Flowline |
| <input checked="" type="checkbox"/> Crude oil theft (illegal bunkering) point | <input type="checkbox"/> Saver-pit over flow | <input type="checkbox"/> Third party tampering with Clamp |

A SECTION OF 12" IMO RIVER - OGALE PIPELINE AT OGALE SHOWING A 1" BALL VALVE WITH LOCALLY FABRICATED CLAMP INSTALLED AT 12 O'CLOCK POSITION BY UNKNOWN PERSONS.
