# JOINT INVESTIGATION REPORT

INCIDENT NO: 2326071 JIV report S/N: 0296

1. Spill incident Number: 2326071 2. Type of incident\* OIL SPILL  
3. Name of Location: 10" DISBU - NUN RIVER DELIVERY LINE (PIPELINE)  
4. Name of nearest community: ONYOMA/EKOWE, State: BAYELSA 6. LGA: SOUTHERN-LSAN  
7. Type of Production facility/Installation: OIL PIPELINE  
8. Asset owner/District: THE SHELL PETROLEUM DEVELOPMENT COMPANY OF NIGERIA LIMITED/PIPELINE

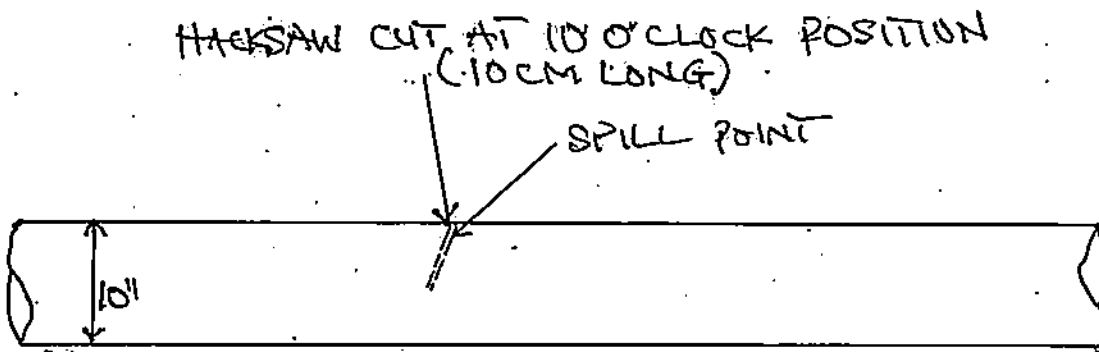
**E. GRAPHIC DESCRIPTION OF LEAK POINT** (while detailed report of the leak point should be contained in the leak report, overview sketch of the site should be added as an appendix 1) A SECTION OF 10" DIEBU - NUN RIVER DELIVERY LINE (PIPELINE) AT ONYOMAEKOLE SHOWING A HACKSAW CUT AT 10 O' CLOCK POSITION BY UNKNOWN PERSONS.

Cause:Third Party Interference ( Arc saw cut on the pipe at 10 O clock position.)

REPAIR BY CLAMPING ONGOING

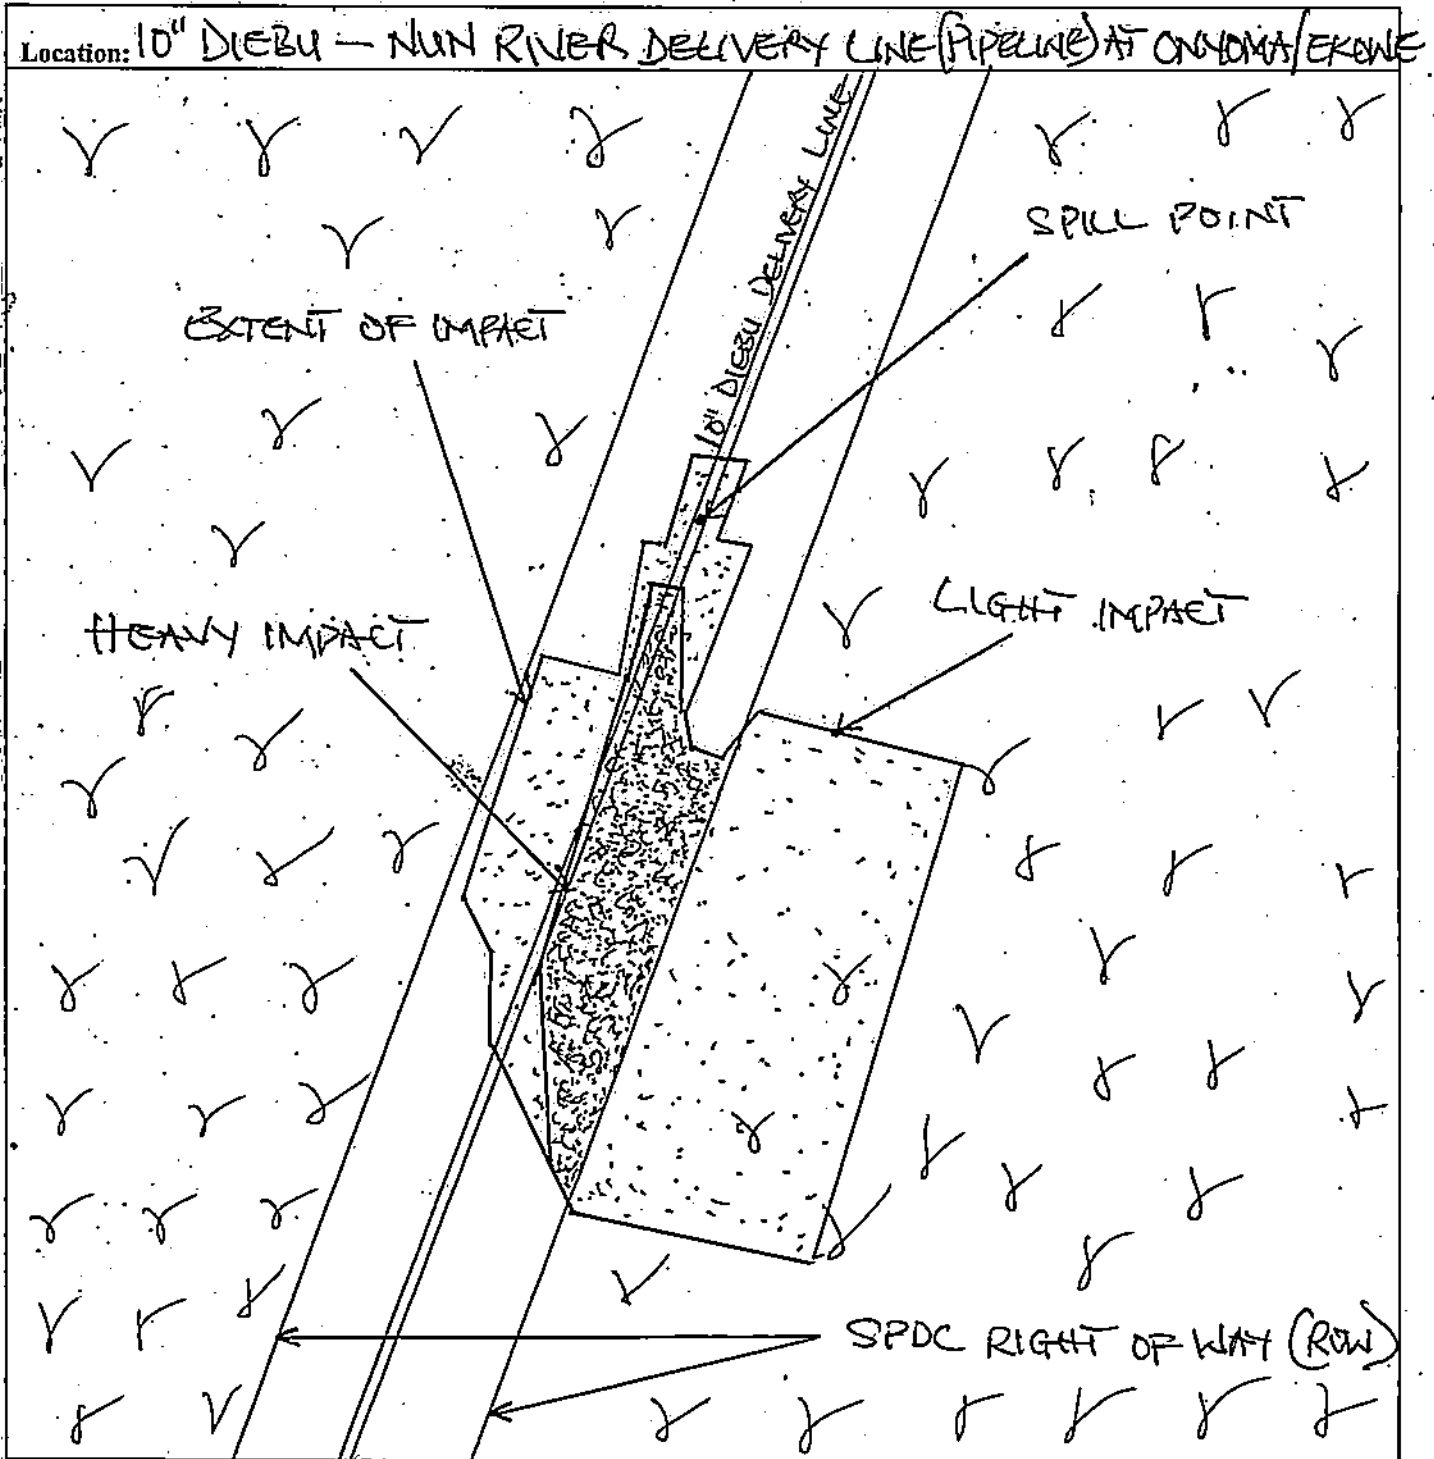
f. Appendix 1: Overview sketch of the site

- Total calculated area of impact 0.519201 HA
- Impact within R.O.W YES
- Impact outside R.O.W YES
