JOINT INVESTIGATION REPORT

INCIDENT NO: 2331302 JIV report S/N: 0113

1. Spill incident Number: 2331302 2. Type of incident*: OIL SPILL
3. Name of Location: 14" OKORDIA - RUMUKEPE PIPELINE
4. Name of nearest community UKPELEDE S. State: RIVERS G.LGA AHOADA WEST
5. Production facility/Installation OIL PIPELINE
8. Asset owner/District THE SHELL PETROLEUM DEVELOPMENT COMPANY OF NIGERIA LIMITED / PIPELINE

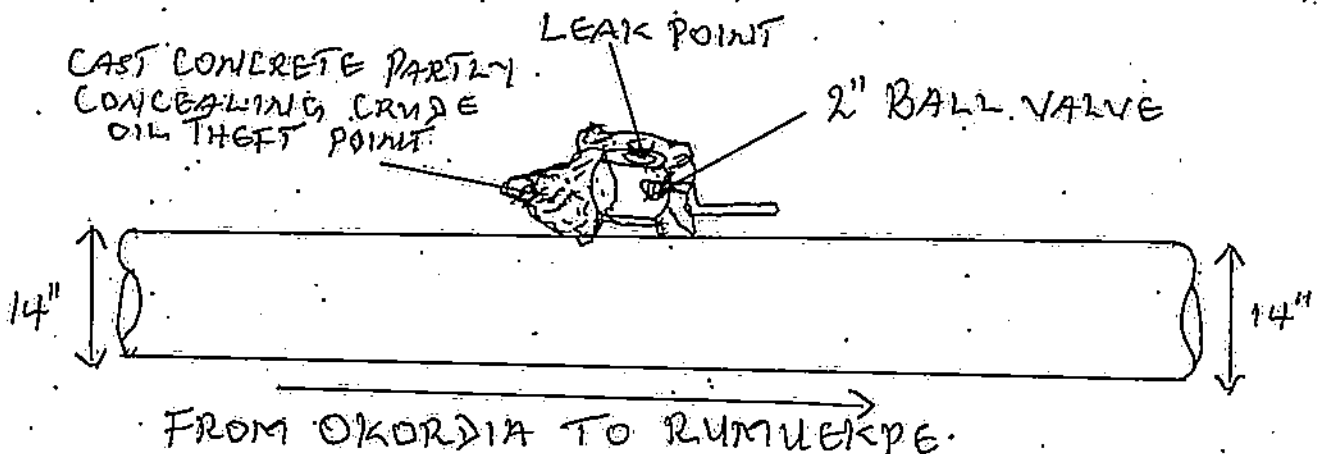
| <input checked="" type="checkbox"/> Failed Weld-on illegal hot tap valve | <input type="checkbox"/> Failed Clamp | <input type="checkbox"/> Missing Pipeline/Flowline |
| <input checked="" type="checkbox"/> Crude oil theft (illegal bunkering) point | <input type="checkbox"/> Saver-pit over flow | <input type="checkbox"/> Third party tampering with Clamp |

SECTION OF 14" OKORDIA - RUMUKEPE PIPELINE AT UNRELIABLE SHOWING CRUDE OIL THEFT POINT AT 12 O'CLOCK POSITION.

REPAIR AND RECOVERY ACTIVITIES ARE ONGOING

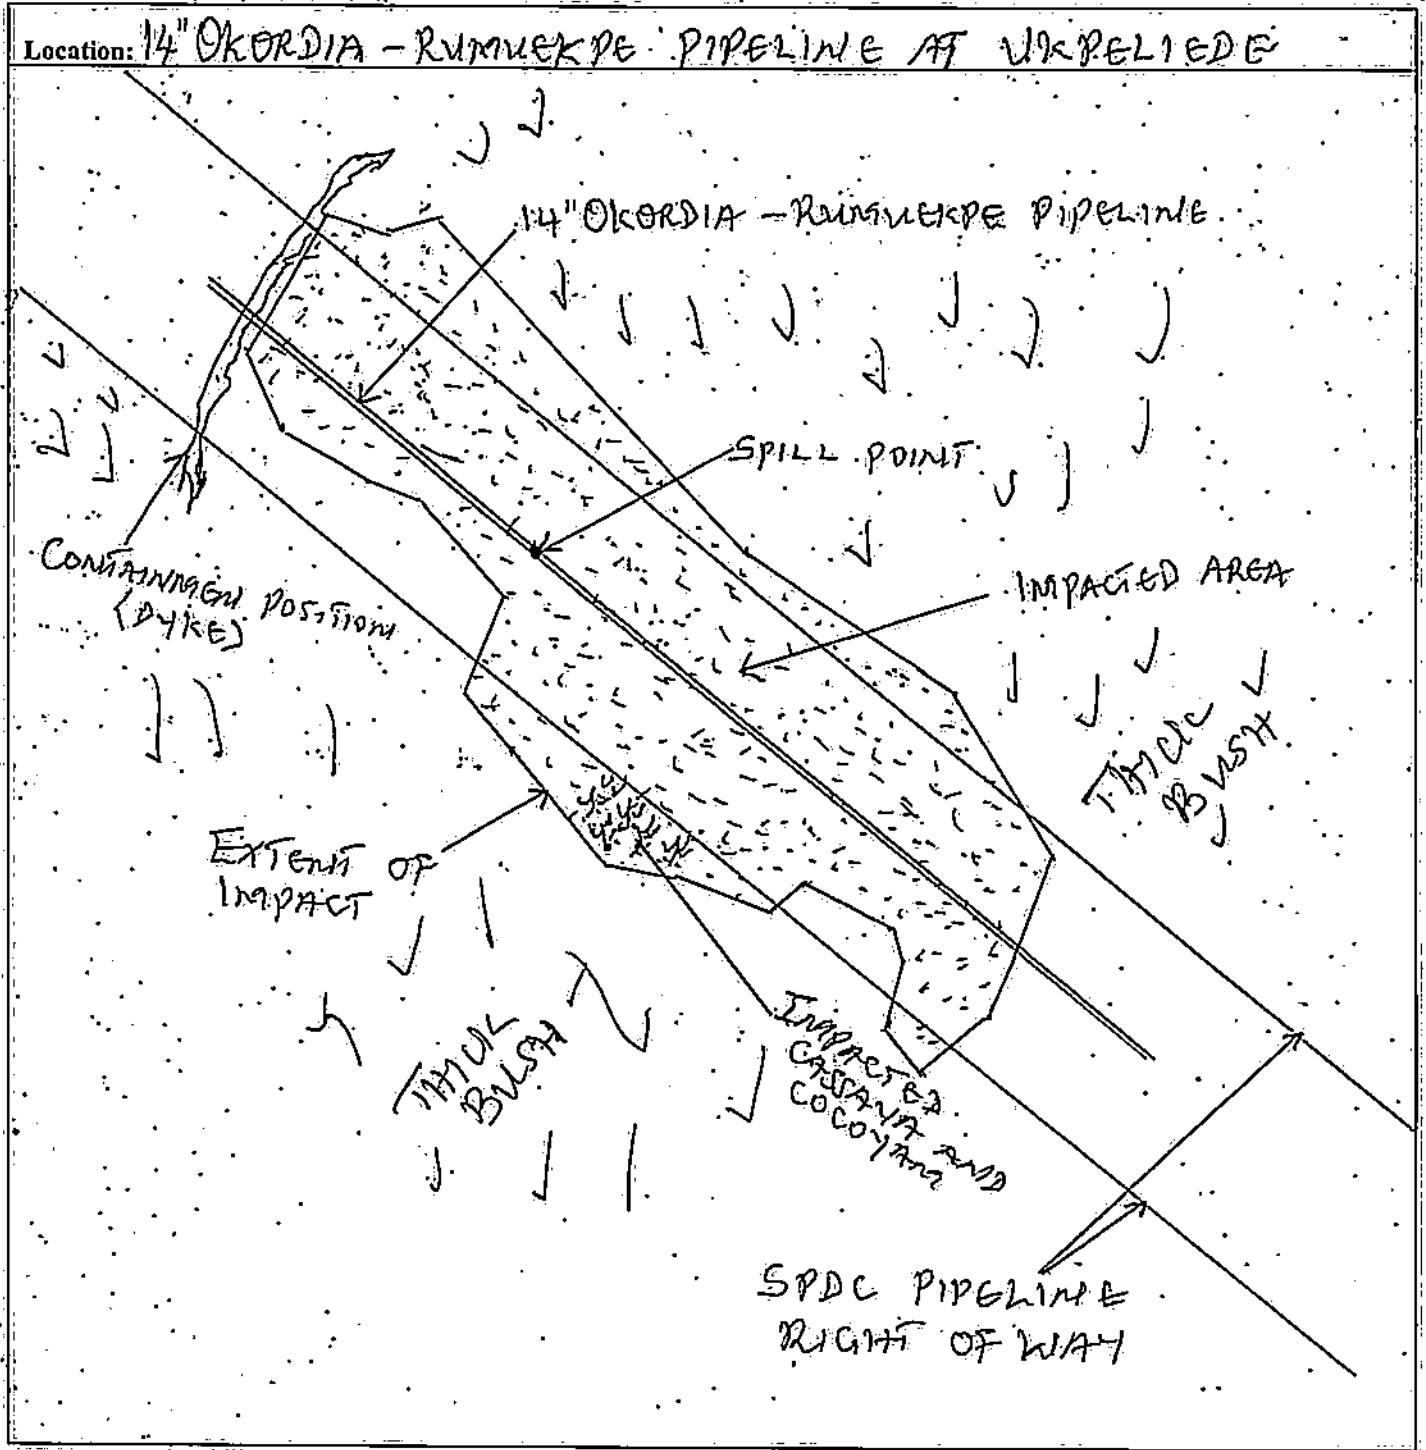
f. Appendix I: Overview sketch of the site

- Total calculated area of impact 0.36203 Ha
- Impact within R.O.W YES
- Impact outside R.O.W YES
