# JOINT INVESTIGATION REPORT

INCIDENT NO: 2331867 JIV report S/N: 0294

1. Spill incident Number: 2331867 2. Type of incident\*: OIL SPILL  
3. Name of Location: 12" IMO RIVER 2 - OGALE PIPELINE  
4. Name of nearest community: IGIPIUKKIU OWAZA 5. State: ABIA 6. LGA: UKWA-WEST  
7. Type of Production facility/Installation: OIL PIPELINE  
8. Asset owner/District: THE SHELL PETROLEUM DEVELOPMENT COMPANY OF NIGERIA LIMITED (SPDC) / PIPELINE

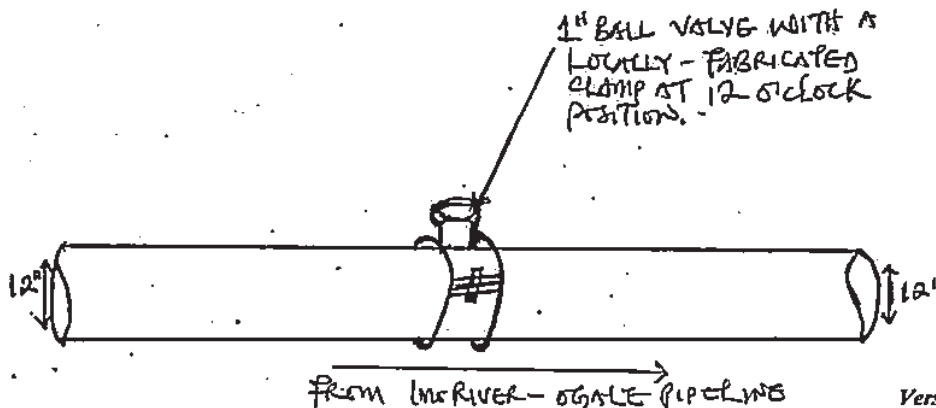
**E. GRAPHIC DESCRIPTION OF LEAK POINT** (while detailed report of the leak point should be contained in the leak report, overview sketch of the site should be added as an appendix 1) A SECTION OF 12" INS RIVER-OGALE PIPELINE AT ONIWA SHOWING A 1" BALL VALVE AND A LOCALLY FABRICATED CLAMP AT 12 O'CLOCK POSITION BY UNKNOWN PERSONS.
