JOINT INVESTIGATION REPORT

INCIDENT NO: 2317463 JIV report S/N:0275

1. Spill incident Number: 2317463 2. Type of incident*: OIL SPILL
3. Name of Location 16" EGEMA-ASSA (TRUNK LINE) PIPELINE
4. Name of nearest community OBILE 5. State: IMO 6. LGA OHAJI EGBEMA
7. Type of Production facility/Installation OIL PIPELINE
8. Asset owner/District THE SHELL PETROLEUM DEVELOPMENT COMPANY OF NIGERIA LIMITED / PIPELINE

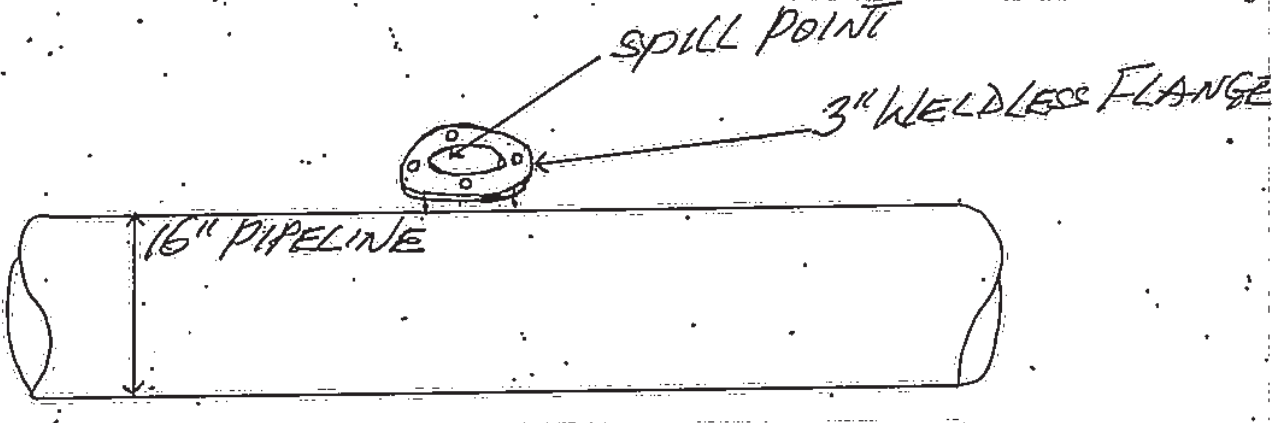
Additional observations around the spill point: ON EXCAVATION OF THE INCIDENT POINT THE JOINT INVESTIGATION TEAM OBSERVED THE USE OF SAND BAGS TO CONCEAL THE ILLEGAL THEFT POINT.

| <input checked="" type="checkbox"/> Failed Weld-on illegal hot tap valve | <input type="checkbox"/> Failed Clamp | <input type="checkbox"/> Missing Pipeline/Flowline |
| <input checked="" type="checkbox"/> Crude oil theft (illegal bunkering) point | <input type="checkbox"/> Saver-pit over flow | <input type="checkbox"/> Third party tampering with Clamp |

A SECTION OF 16" EGBEMA-ASSA (TRUNKLINE) PIPELINE AT OBILE SHOWING A 3" WELDLESS FLANGE INSTALLED AT 12 O'CLOCK POSITION BY UNKNOWN PERSONS.

REPAIR BY CLAMPING ONGOING
