JOINT INVESTIGATION REPORT

INCIDENT NO: 2333194 JIV report S/N: 0134

- 1. Spill incident Number: 2333194 2. Type of incident*: OIL SPILL
- 3. Name of Location 6th TUNU KANBO WELL 7L FLOWLINE
ERBEND-ANALABIRI
- 4. Name of nearest community: AGBIDAMA 5. State: BAYELSA 6. LGA EKEREMOR
- 7. Type of Production facility/Installation OIL FLOWLINE
- 8. Asset owner/District THE SHELL PETROLEUM DEVELOPMENT COMPANY OF NIGERIA LIMITED / TUNU

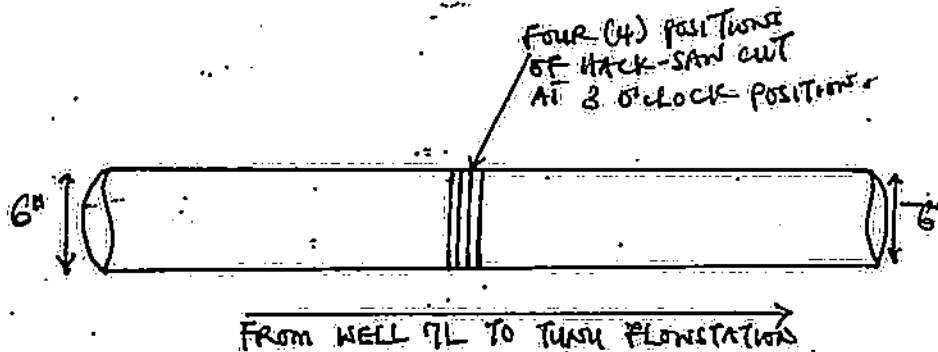
E. GRAPHIC DESCRIPTION OF LEAK POINT (while detailed report of the leak point should be contained in the leak report, overview sketch of the site should be added as an appendix 1) A SECTION OF 6" TUNN KANBO WELL 7L FLOWING AT EGBEMO-ANALABIAI SHOWING FOUR (4) POSITIONS OF HACK-SAW CUT AT 3 O'CLOCK POSITION.
