# JOINT INVESTIGATION REPORT

INCIDENT NO: 2344333 JIV report S/N: 0130

1. Spill incident Number: 2344333 2. Type of incident\*: FLOWLINE THEFT
3. Name of Location 4<sup>th</sup> OPURUSTHI WELL 33 L/S FLOWLINE  
EGBEND- ANCALABIRI
4. Name of nearest community AGBIDIANA 5. State: BAYELSA 6. LGA EKEREMOR
7. Type of Production facility/Installation OIL FLOWLINE
8. Asset owner/District THE SHELL PETROLEUM DEVELOPMENT COMPANY OF NIGERIA LIMITED (SPDC)

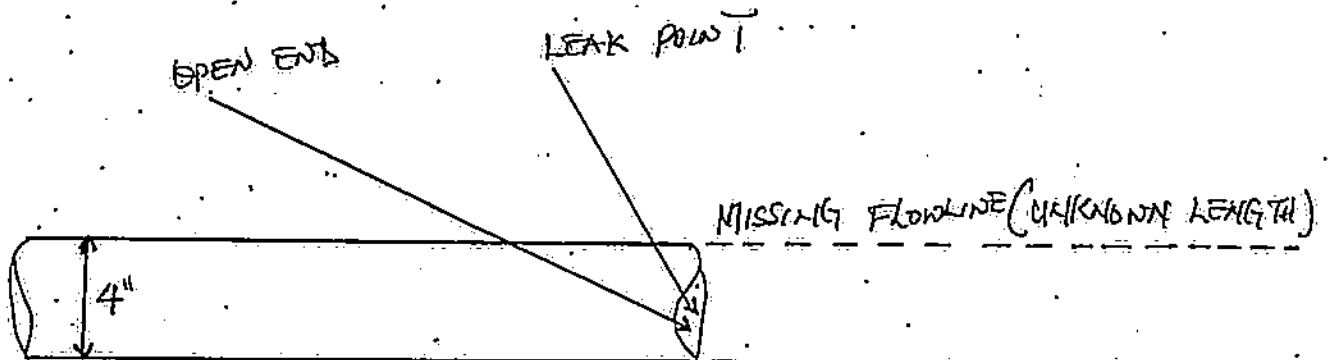
| <input type="checkbox"/> Failed Weld-on-illegal hot tap valve | <input type="checkbox"/> Failed Clamp | <input checked="" type="checkbox"/> Missing Pipeline/Flowline |

**E. GRAPHIC DESCRIPTION OF LEAK POINT** (while detailed report of the leak point should be contained in the leak report, overview sketch of the site should be added as an appendix 1) A SECTION OF 4" OPUKUSHI WELL 33 L/S FLOWLINE AT AGIBIYAMA SHOWING MISSING FLOWLINE (THEFT).
