JOINT INVESTIGATION REPORT

INCIDENT NO: 2312667 JIV report S/N: 0118

1. Spill incident Number: 2312667 2. Type of incident* OIL SPILL
3. Name of Location 20" KOLOCREEK - RUMUETAPE PIPELINE
4. Name of nearest community ODAU (KM19) 5. State: RIVERS 6. LGA ABUJA/ODUAL
7. Type of Production facility/Installation OIL PIPELINE
8. Asset owner/District THE SHELL PETROLEUM DEVELOPMENT COMPANY OF NIGERIA LIMITED / PIPELINE

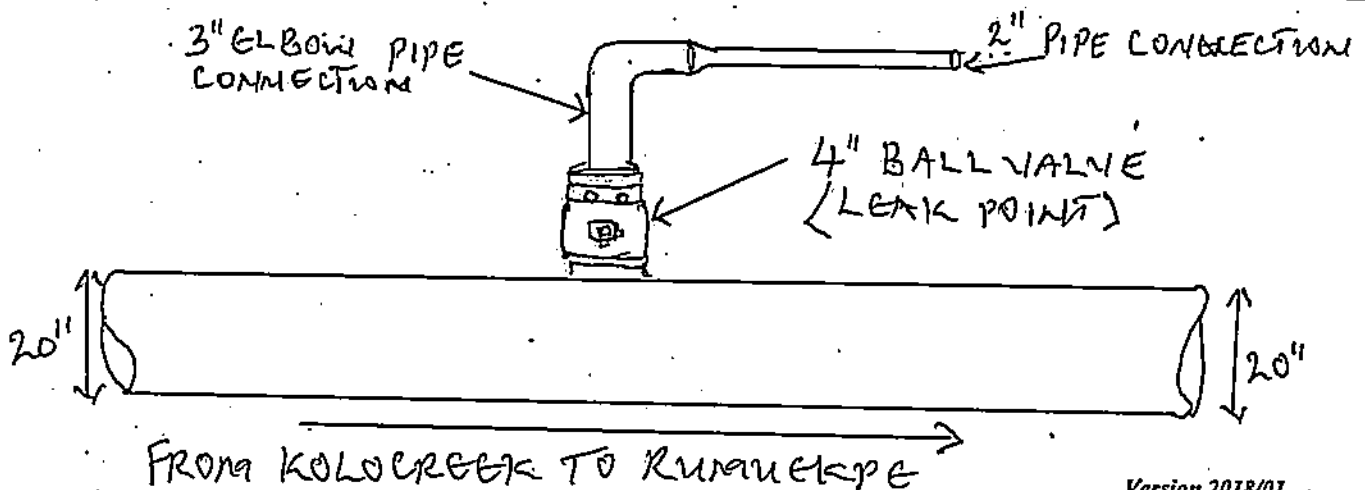
Additional observations around the spill point: THE JOINT INVESTIGATION TEAM OBSERVED 4" BALL VALVE ILLEGALLY INSTALLED AT 12 O'CLOCK POSITION ON 20" KOLOCREEK - RUMUETAPE PIPELINE AT ODAU (KM19)

SECTION OF 20" KOLOCREEK - RUMUKEPE PIPELINE AT ODALL (KM 19) SHOWING CRUDE OIL LEAK POINT AT 12 O' CLOCK POSITION.
