JOINT INVESTIGATION REPORT

INCIDENT NO: 2417937 JIV report S/N: 1030091

1. Fountain Incident Number: 2417937 2. Type of incident* OIL SPILL
3. Name of Location 20" KOLD CREEK - RUMUEKPE PIPELINE
4. Name of nearest community OKPDRWO 5. State: RIVERS 6. LGA AHOADA EAST
7. Type of Production facility/Installation OIL PIPELINE
8. Asset owner/District THE SHELL PETROLEUM DEVELOPMENT COMPANY OF NIGERIA LTD (SPDC) / PIPELINE

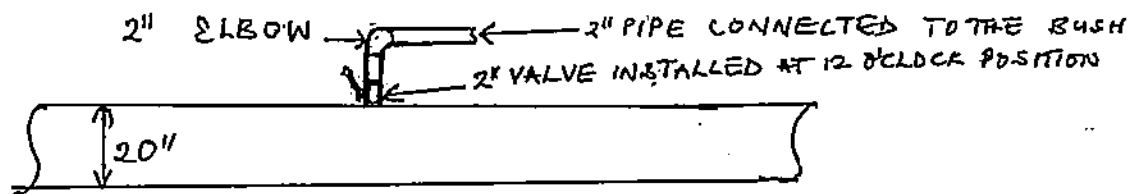
E. GRAPHIC DESCRIPTION OF LEAK POINT (while detail report of the leak point should be contained in the leak report, overview sketch of the site should be added as an appendix 1) A SECTION OF 20" KORO CREEK RUMU EKPE PIPELINE AT OKPORDO SHOWING 2" CRUDE THEFT VALVE BANK INSTALLED AT 12 O'CLOCK POSITION BY UNKNOWN PERSONS.

BLINDING
