JOINT INVESTIGATION REPORT

INCIDENT NO: 2428590 JIV report S/N: 1030106

1. Fountain Incident Number: 2428590 2. Type of incident* OIL SPILL
3. Name of Location 16" EGBEMA - ASSA PIPELINE
4. Name of nearest community OBILE 5. State: IMD 6. LGA OHAFI / EGBEMA
7. Type of Production facility/Installation OIL PIPELINE
8. Asset owner/District THE SHELL PETROLEUM DEVELOPMENT COMPANY
OF NIGERIA LIMITED / PIPELINE

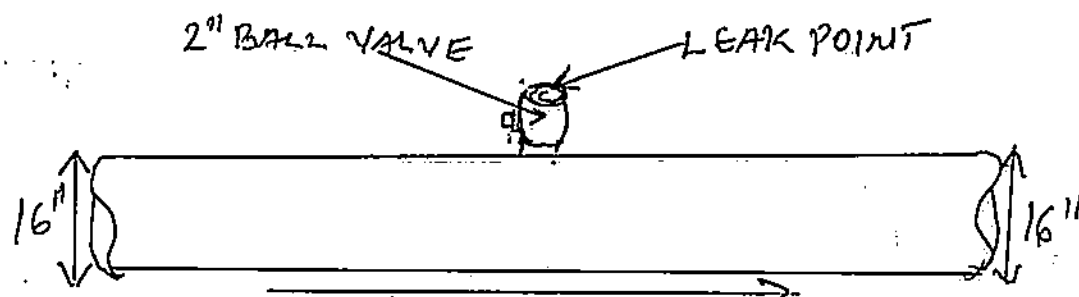
| <input checked="" type="checkbox"/> Failed Weld-on illegal hot tap valve | <input type="checkbox"/> Failed Clamp, | <input type="checkbox"/> Missing Pipeline/Flowline |
| <input checked="" type="checkbox"/> Crude oil theft (illegal bunkering) point, | <input type="checkbox"/> Saver-pit over flow | <input type="checkbox"/> Third party tampering with Clamp |

SECTION OF 16" EGBEMA - ASSA PIPELINE AT OBILE SHOWING CRUDE OIL THEFT POINT INSTALLED AT 12 O'CLOCK POSITION.

RECOVERY AND REPAIR ACTIVITIES COMPLETED.
