# JOINT INVESTIGATION REPORT

INCIDENT NO: 2429471 JIV report S/N: 1030081

1. Fountain Incident Number: 2429471 2. Type of incident\* OIL SPILL  
3. Name of Location 24<sup>th</sup> NKPOKU - BOMU PIPELINE (ONP)  
4. Name of nearest community EGBALOR 5. State: RIVERS 6. LGA ELUME  
7. Type of Production facility/Installation OIL PIPELINE  
8. Asset owner/District THE SHELL PETROLEUM DEVELOPMENT COMPANY OF NIGERIA LIMITED / PIPELINE

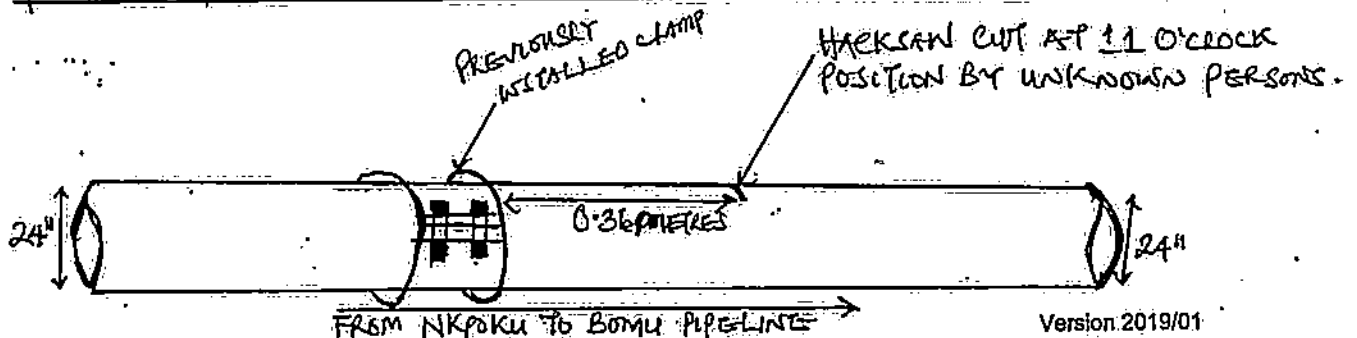
**E. GRAPHIC DESCRIPTION OF LEAK POINT** (while detail report of the leak point should be contained in the leak report, overview sketch of the site should be added as an appendix 1) A SECTION OF 24" NKPOKU-BOMU PIPELINE (TNP) AT EGBADOR SHOWING A HACKSAW CUT AT 11 O'CLOCK POSITION BY UNKNOWN PERSONS AND A PREVIOUSLY INSTALLED CLAMP.
