JOINT INVESTIGATION REPORT

INCIDENT NO: 2417124 JIV report S/N: 1030100

1. Fountain Incident Number: 2417124 2. Type of incident: OIL SPILL
3. Name of Location: 24" Nkpoku - BOMU PIPELINE
4. Name of nearest community: EGBALOR 5. State: RIVERS 6. LGA: ELEME
7. Type of Production facility/Installation: OIL PIPELINE
8. Asset owner/District: THE SHELL PETROLEUM DEVELOPMENT COMPANY OF NIGERIA LIMITED / PIPELINE

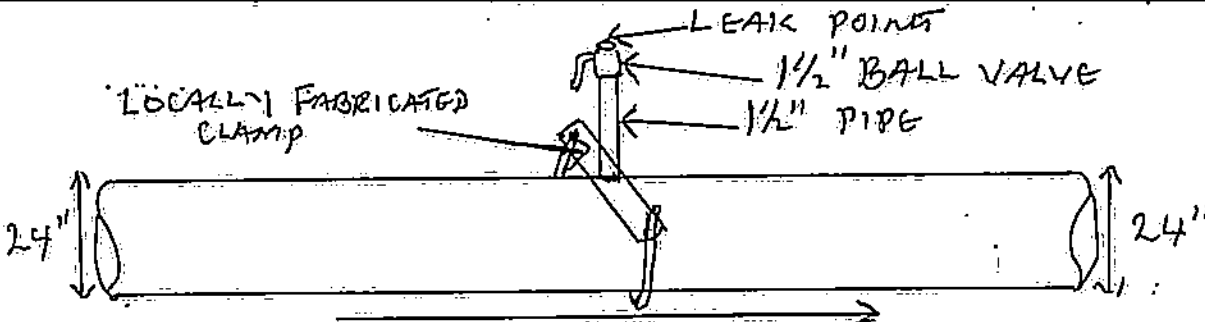
Additional observations around the spill point: JOINT INVESTIGATION TEAM IDENTIFIED THE CAUSE OF SPILL TO BE OPEN CRUDE OIL STEALING VALVE. VALVE WAS CLOSED AND PLAN FOR REMOVAL / REPAIR COMMENCED. REMOVAL OF SUBJECT ILLEGAL CONNECTION WILL BE SCHEDULED ALONG WITH THE INTEGRATED REPAIR CAMPAIGN.

| <input checked="" type="checkbox"/> Failed Weld-on illegal hot tap valve | <input type="checkbox"/> Failed Clamp, | <input type="checkbox"/> Missing Pipeline/Flowline |

SECTION OF 24" NKPOKU - BOMU PIPELINE AT EGBALOR SHOWING CRUDE OIL THEFT POINT INSTALLED AT 12 O'CLOCK POSITION.

[Y] VALVE CLOSED AND PERMANENT REPAIR PLANNED.
