JOINT INVESTIGATION REPORT

INCIDENT NO: 2426828 JIV report S/N: 1030107

1. Fountain Incident Number: 2426828 2. Type of incident: OIL SPILL
3. Name of Location: 20" KOLOCREEK - RUMUEKPE PIPELINE
4. Name of nearest community OKPDROND 5. State: RIVERS 6. LGA AHOADA EAST
7. Type of Production facility/Installation: OIL PIPELINE
8. Asset owner/District: THE SHELL PETROLEUM DEVELOPMENT COMPANY OF NIGERIA LTD (SPDC) / PIPELINE

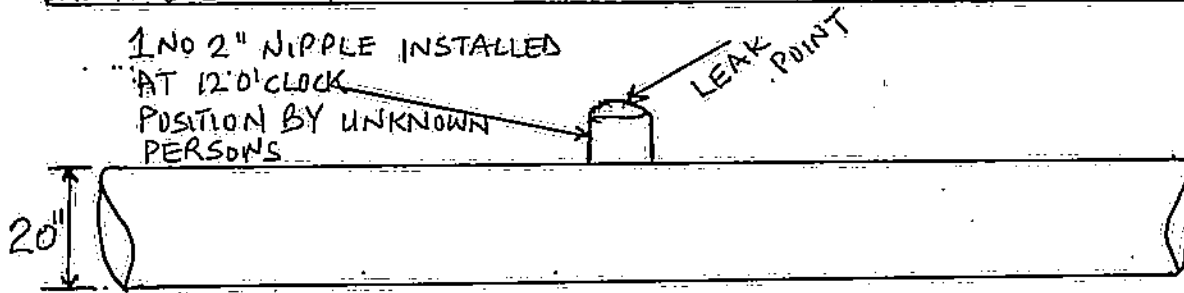
| <input checked="" type="checkbox"/> Crude oil theft (illegal bunkering) point | <input type="checkbox"/> Saver-pit over flow | <input type="checkbox"/> Third party tampering with Clamp |

E. GRAPHIC DESCRIPTION OF LEAK POINT (while detail report of the leak point should be contained in the leak report, overview sketch of the site should be added as an appendix 1) A SECTION OF 20" KOLD CREEK-RUMUEKPE PIPELINE AT OKPDROWD SHOWING 1ND OF 2" NIPPLE INSTALLED AT 12 O'CLOCK POSITION BY UNKNOWN PERSONS.

REPAIR BY CLAMPING
