# JOINT INVESTIGATION REPORT

INCIDENT NO: 242 9394 JIV report S/N: 1030108

1. Fountain Incident Number: 242 9394 2. Type of incident\* OIL SPILL  
3. Name of Location 8" UBIE DELIVERY LINE BARREL UKPELEDE MANIFOLD  
4. Name of nearest community UKPELEDE 5. State: RIVERS 6. LGA AHOADA WEST  
7. Type of Production facility/Installation PIPELINE MANIFOLD  
8. Asset owner/District THE SHELL PETROLEUM DEVELOPMENT COMPANY OF NIGERIA LTD (SPD) / PIPELINE

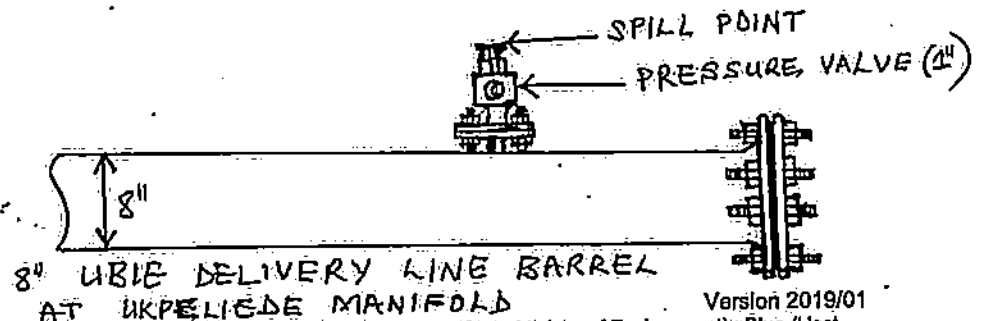
| <input checked="" type="checkbox"/> Third party tampering with valve setting | <input type="checkbox"/> Bulging Outward | <input type="checkbox"/> Third party tampering with flange, |

**E. GRAPHIC DESCRIPTION OF LEAK POINT** (while detail report of the leak point should be contained in the leak report, overview sketch of the site should be added as an appendix 1) A SECTION OF 8" UBLE DELIVERY LINE BARREL AT UKPELEDE MANIFOLD SHOWING 1" PRESSURE VALVE WITHOUT THE PLUG, REMOVED BY UNKDOWN PERSONS.

PRESSURE VALVE PLUG REPLACEMENT.
