# JOINT INVESTIGATION REPORT

INCIDENT NO: 2434741 JIV report S/N: 1030096

1. Fountain Incident Number: 2434741 2. Type of incident\* OIL SPILL  
3. Name of Location 16" EGBEMA - ASSA PIPELINE  
4. Name of nearest community ETEKWURU 5. State: IMO 6. LGA OHAI/EGBEMA  
7. Type of Production facility/Installation OIL PIPELINE  
8. Asset owner/District THE STEEL PETROLEUM DEVELOPMENT COMPANY OF NIGERIA LIMITED (SPDC)/PIPELINE

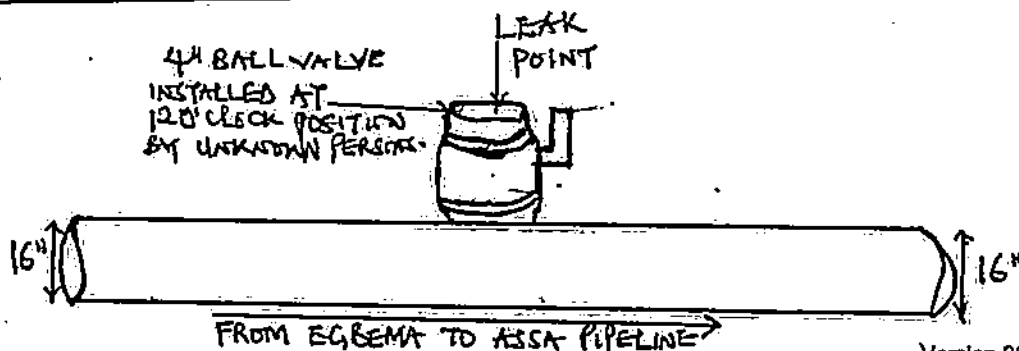
Additional observations around the spill point: THE SPILL INCIDENT POINT WAS OBSERVED TO BE THE SAME LOCATION AS PREVIOUSLY REPORTED CRUDE OIL IN A PIT. (INCIDENT NUMBERS - 2421255 AND 2422140).

| <input checked="" type="checkbox"/> Failed Weld-on illegal hot tap valve | <input type="checkbox"/> Failed Clamp, | <input type="checkbox"/> Missing Pipeline/Flowline |
| <input checked="" type="checkbox"/> Crude oil theft (illegal bunkering) point, | <input type="checkbox"/> Saver-pit over flow | <input type="checkbox"/> Third party tampering with Clamp |

**E. GRAPHIC DESCRIPTION OF LEAK POINT** (while detail report of the leak point should be contained in the leak report, overview sketch of the site should be added as an appendix) SECTION OF 16" EGBEMA-ASSA PIPELINE AT ETERWURU SHOWING A 4" BALL VALVE INSTALLED AT 12 O'CLOCK POSITION BY UNKNOWN PERSONS.

REPAIR BY CLAMPING
