# JOINT INVESTIGATION REPORT

INCIDENT NO: 2435483 JIV report S/N: 1030109

1. Fountain Incident Number: 2435483 2. Type of incident\* OIL SPILL  
3. Name of Location 18" ASSA - RUMNEKPE PIPELINE  
4. Name of nearest community EGBEDA 5. State: RIVERS 6. LGA EMOHUA  
7. Type of Production facility/Installation OIL PIPELINE  
8. Asset owner/District THE SHELL PETROLEUM DEVELOPMENT COMPANY OF NIGERIA LIMITED / PIPELINE

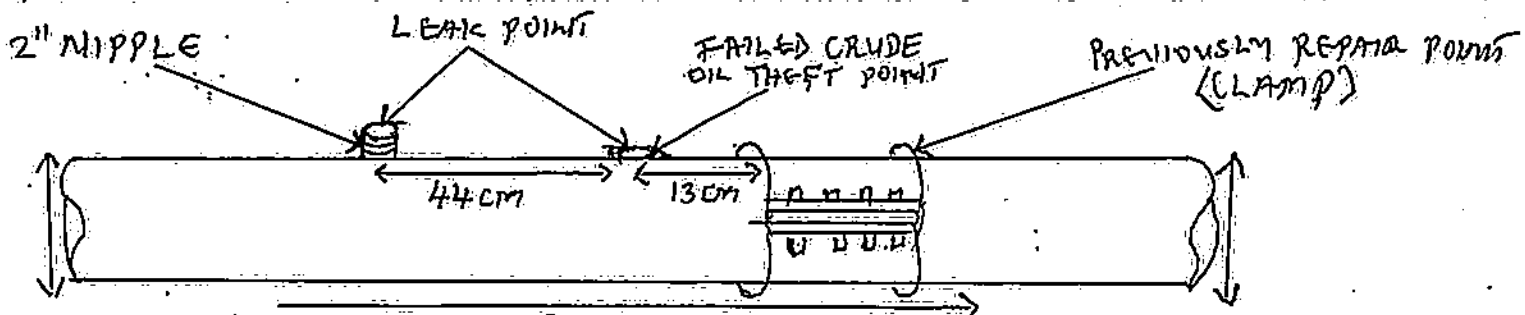
**E. GRAPHIC DESCRIPTION OF LEAK POINT** (while detail report of the leak point should be contained in the leak report, overview sketch of the site should be added as an appendix 1)

| <input checked="" type="checkbox"/> Failed Weld-on illegal hot tap valve | <input type="checkbox"/> Failed Clamp, | <input type="checkbox"/> Missing Pipeline/Flowline |
| <input checked="" type="checkbox"/> Crude oil theft (illegal bunkering) point, | <input type="checkbox"/> Saver-pit over flow | <input type="checkbox"/> Third party tampering with Clamp |

SECTION OF 18" ASSA - RUMVEKPE PIPELINE AT EGBEDA SHOWING 2 NO OF CRUDE OIL THEFT POINT INSTALLED AT 12 O'CLOCK POSITION.

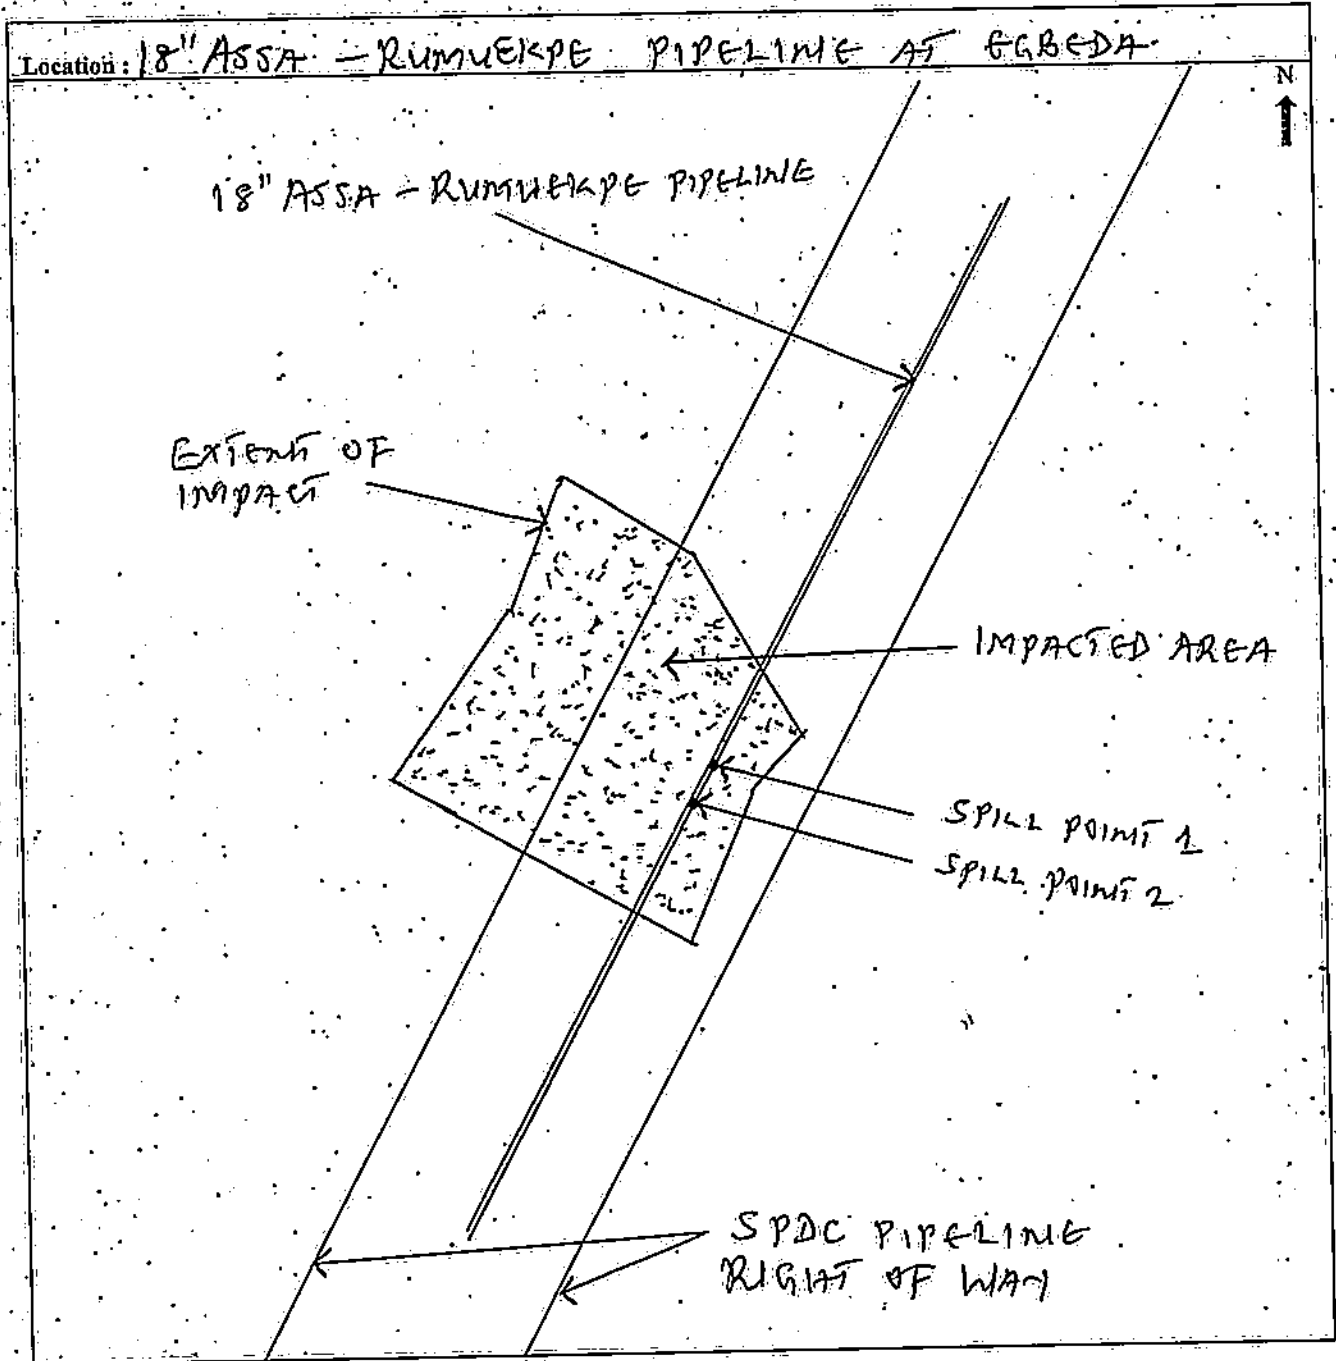
f. Appendix 1: Overview sketch of the site

Additional observations around the spill point:  
SAND BAGS AND ONGOING REMEDIATION ACTIVITIES WERE OBSERVED AROUND THE SPILL POINT.

- Total calculated area of impact 0.071 HA
- Impact within SPDC R.O.W. YES
- Impact outside SPDC R.O.W. YES
