JOINT INVESTIGATION REPORT

INCIDENT NO: 2019-2436880 JIV report S/N: 1030128

1. Fountain Incident Number: 2019-2436880 2. Type of incident* OIL SPILL
3. Name of Location 12" Imo RIVER 2 - OGALE T/L AT UMUOLOLO (PIPELINE)
4. Name of nearest community UMUOLOLO 5. State: ABIA 6. LGA UKWA WEST
7. Type of Production facility/Installation OIL PIPELINE
8. Asset owner/District THE STELL PETROLEUM DEVELOPMENT COMPANY OF NIGERIA LIMITED (SPDC) / PIPELINE

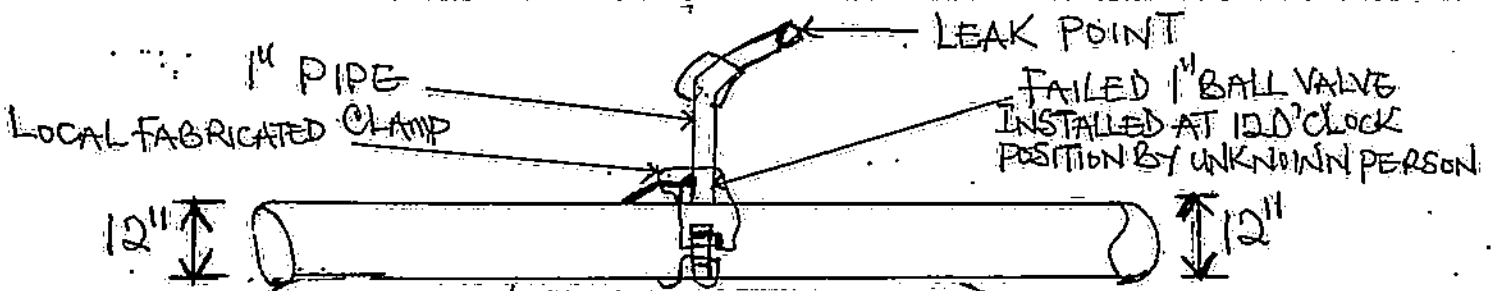
| <input checked="" type="checkbox"/> Crude oil theft (illegal bunkering) point, | <input type="checkbox"/> Saver-pit over flow | <input type="checkbox"/> Third party tampering with Clamp |

E. GRAPHIC DESCRIPTION OF LEAK POINT (while detail report of the leak point should be contained in the leak report, overview sketch of the site should be added as an appendix 1) A SECTION OF 12" IMP. RIVER 2-OGALE PIPELINE AT UMUDOLO SHOWING INGS OF 1" BALL VALVE INSTALLED AT 12.0 O'CLOCK POSITION BY UNKNOWN PERSON

REPAIR BY CLAMPING ON GOING.
