JOINT INVESTIGATION REPORT

INCIDENT NO: 2441903 JIV report S/N: 1030095

1. Fournain Incident Number: 2441903 2. Type of incident* OIL SPILL
3. Name of Location 20" KUMUEKPE - NKPOKU PIPELINE
4. Name of nearest community IBAA 5. State: RIVERS 6. LGA EMOHUA
7. Type of Production facility/Installation OIL PIPELINE
8. Asset owner/District THE SHELL PETROLEUM DEVELOPMENT COMPANY OF NIGERIA LIMITED (SPDC) / PIPELINE

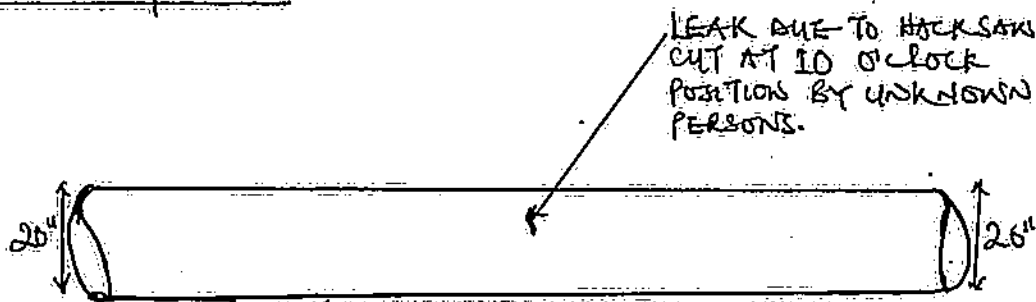
Additional observations around the spill point: THE SPILL POINT IS THE SAME LOCATION WHERE A PREVIOUS INCIDENT OF CRUDE OIL SEEN IN AN EXCAVATED PIT DUG BY UNKNOWN PERSONS WAS REPORTED (INCIDENT NO - 2402875).

| <input type="checkbox"/> Drilled hole | <input checked="" type="checkbox"/> Hack saw cut | <input type="checkbox"/> Tear (_____) |

E. GRAPHIC DESCRIPTION OF LEAK POINT (while detail report of the leak point should be contained in the leak report, overview sketch of the site should be added as an appendix 1) A SECTION OF 20" RUMUGPE-NKPOKU PIPELINE AT IBAA SHOWING A HACKSAW CUT AT 10 O'CLOCK POSITION BY UNKNOWN PERSONS.
