JOINT INVESTIGATION REPORT

INCIDENT NO: 2443760 JIV report S/N: 1030132

1. Fountain Incident Number: 2443760 2. Type of incident: OIL SPILL
3. Name of Location: 28" NKPOKU - BDMU PIPELINE
4. Name of nearest community: EJAMAH 5. State: RIVERS 6. LGA: ELEME
7. Type of Production facility/Installation: OIL PIPELINE
8. Asset owner/District: THE SHELL PETROLEUM DEVELOPMENT COMPANY OF NIGERIA LIMITED / PIPELINE

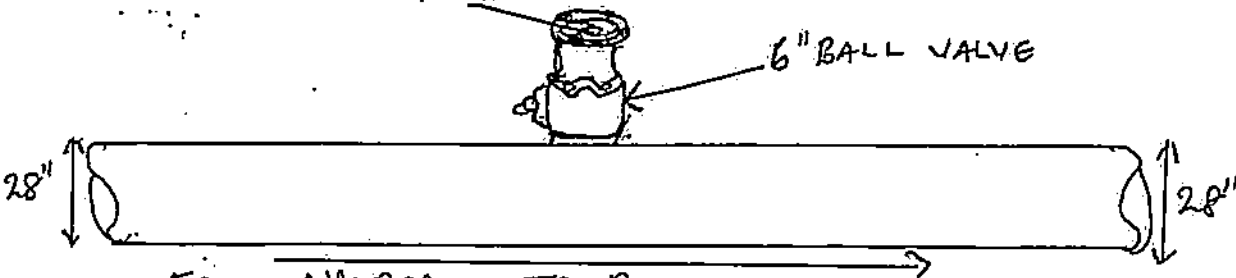
LEAK POINT

| <input checked="" type="checkbox"/> Failed Weld-on illegal hot tap valve | <input type="checkbox"/> Failed Clamp, | <input type="checkbox"/> Missing Pipeline/Flowline |
| <input checked="" type="checkbox"/> Crude oil theft (illegal bunkering) point, | <input type="checkbox"/> Saver-pit over flow | <input type="checkbox"/> Third party tampering with Clamp |

SECTION OF 28" NKPOKU - BOMU PIPELINE AT EJAMAH SHOWING CRUDE OIL THEFT POINTS INSTALLED AT 12 O'CLOCK POSITION.

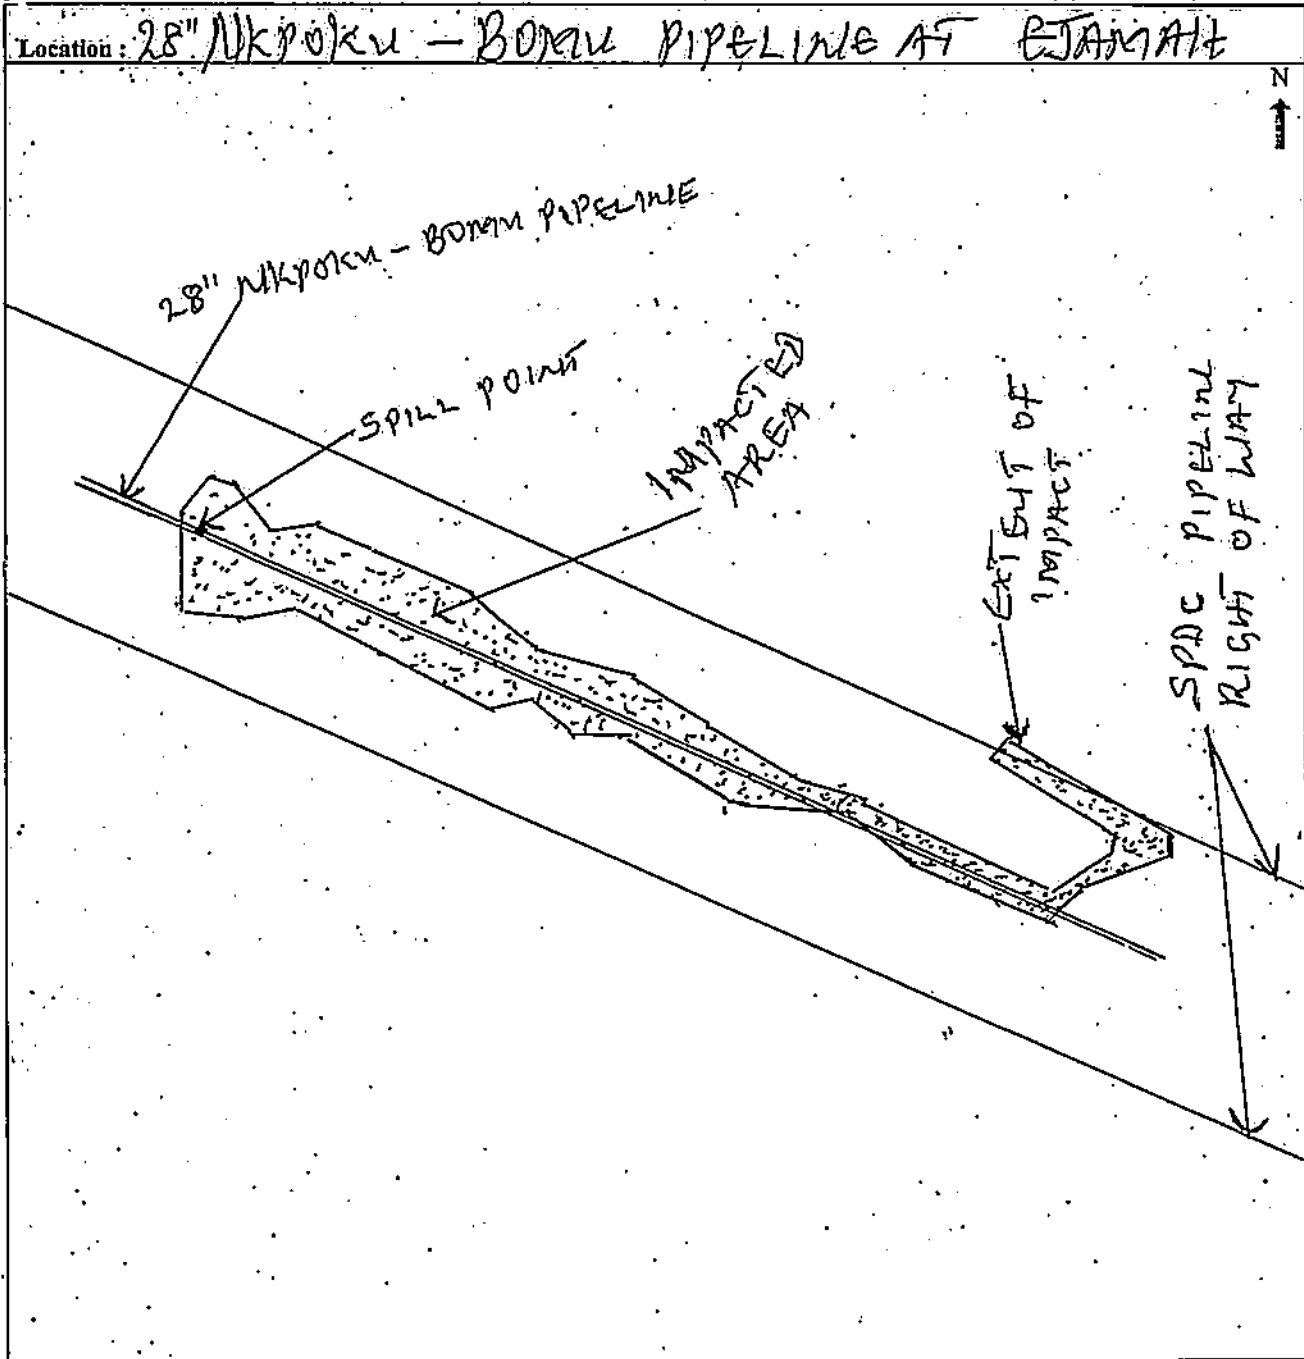
f. Appendix 1: Overview sketch of the site

- Total calculated area of impact 0.19HA
- Impact within SPDC R.O.W. YES
- Impact outside SPDC R.O.W. YES
