# JOINT INVESTIGATION REPORT

INCIDENT NO: 2419671 JIV report S/N: 1030097

1. Fountain Incident Number: 2419671 2. Type of incident\* OIL SPILL AND FIRE  
3. Name of Location 24" NKPOKU - BOMU PIPELINE  
4. Name of nearest community EGBALOR 5. State: RIVERS 6. LGA ELEME  
7. Type of Production facility/Installation OIL PIPELINE  
8. Asset owner/District THE SHELL PETROLEUM DEVELOPMENT COMPANY  
OF NIGERIA LIMITED / PIPELINE.

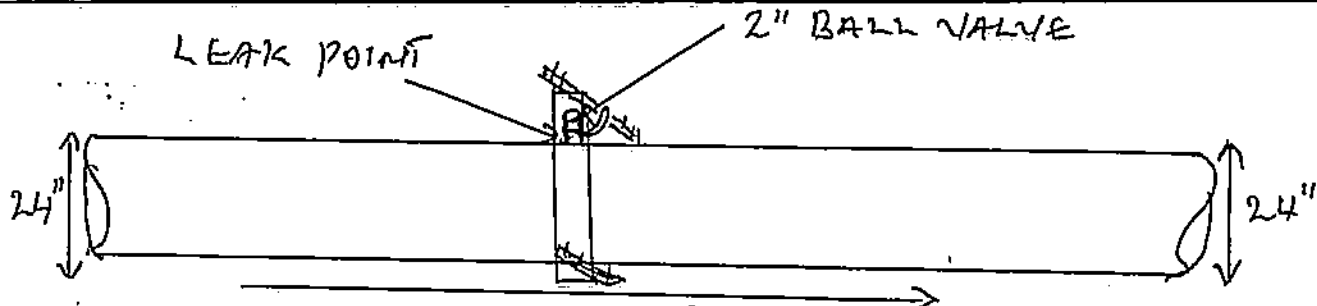
| <input checked="" type="checkbox"/> Failed Weld-on illegal hot tap valve | <input type="checkbox"/> Failed Clamp, | <input type="checkbox"/> Missing Pipeline/Flowline |
| <input checked="" type="checkbox"/> Crude oil theft (illegal bunkering) point, | <input type="checkbox"/> Saver-pit over flow | <input type="checkbox"/> Third party tampering with Clamp |

SECTION OF 24" MKPOKU - BOMU PIPELINE AT EGBALOR SHOWING CRUDE OIL THEFT POINT INSTALLED AT 12 O'CLOCK POSITION
