# JOINT INVESTIGATION REPORT

INCIDENT NO: 2436822 JIV report S/N: 1030127

1. Fountain Incident Number: 2436822 2. Type of incident\* OIL SPILL  
3. Name of Location IMD RIVER WELL 59T FLOWLINE  
4. Name of nearest community IGIRIUKWU 5. State: ABIA 6. LGA UKWA WEST  
7. Type of Production facility/Installation OIL FLOWLINE  
8. Asset owner/District THE SHELL PETROLEUM DEVELOPMENT COMPANY OF NIGERIA LIMITED / LAND EAST HUB

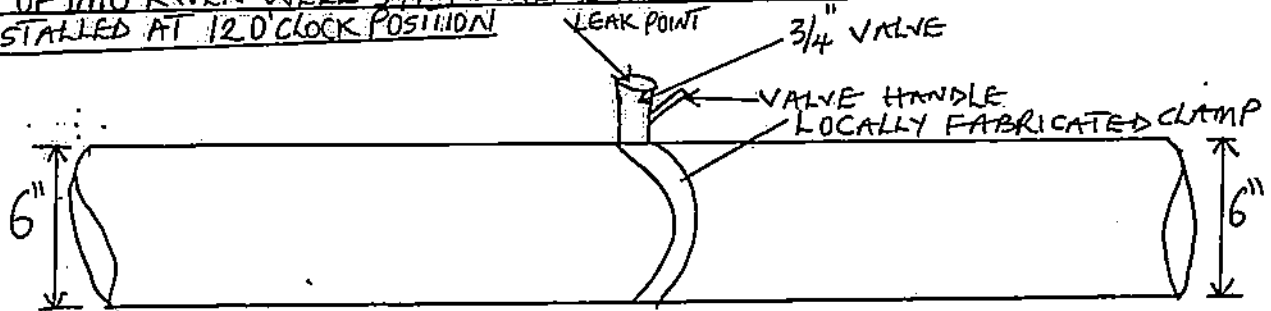
SECTION OF IMO RIVER WELL 59T FLOWLINE AT IGIRUKWU SHOWING CRUDE OIL THEFT POINT INSTALLED AT 12 O'CLOCK POSITION

FROM WELL 59T TO IMO RIVER 3 FLOW STATION  
Version 2019/01
