JOINT INVESTIGATION REPORT

INCIDENT NO: 2439420 JIV report S/N: 1030110

1. Fountain Incident Number: 2439420 2. Type of incident* OIL SPILL
3. Name of Location 14" OKORDIA - Rumuerepe PIPELINE
4. Name of nearest community EDEOHA 5. State: RIVERS 6. LGA AHOADA EAST
7. Type of Production facility/Installation OIL PIPELINE
8. Asset owner/District THE SHELL PETROLEUM DEVELOPMENT COMPANY OF NIGERIA LIMITED / PIPELINE

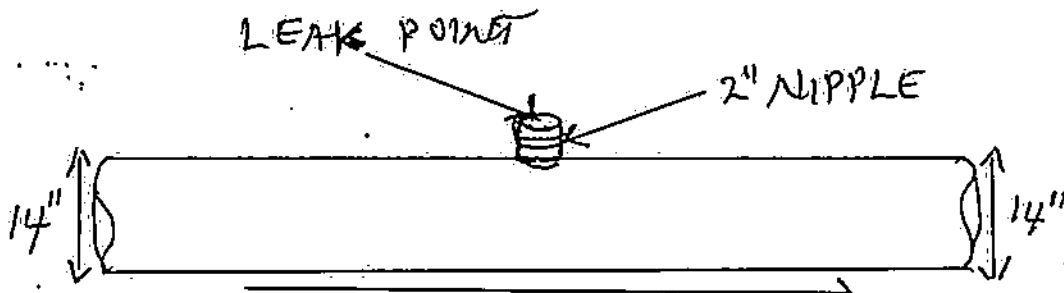
| <input checked="" type="checkbox"/> Failed Weld-on illegal hot tap valve | <input type="checkbox"/> Failed Clamp, | <input type="checkbox"/> Missing Pipeline/Flowline |
| <input checked="" type="checkbox"/> Crude oil theft (illegal bunkering) point, | <input type="checkbox"/> Saver-pit over flow | <input type="checkbox"/> Third party tampering with Clamp |

SECTION OF 14" OKORDIA - RUMUKEPE PIPELINE AT GDEODIA SHOWING CRUDE OIL THEFT POINT INSTALLED AT 12 O'CLOCK POSITION.

REPAIR WORK WAS DONE BY CLAMPING.

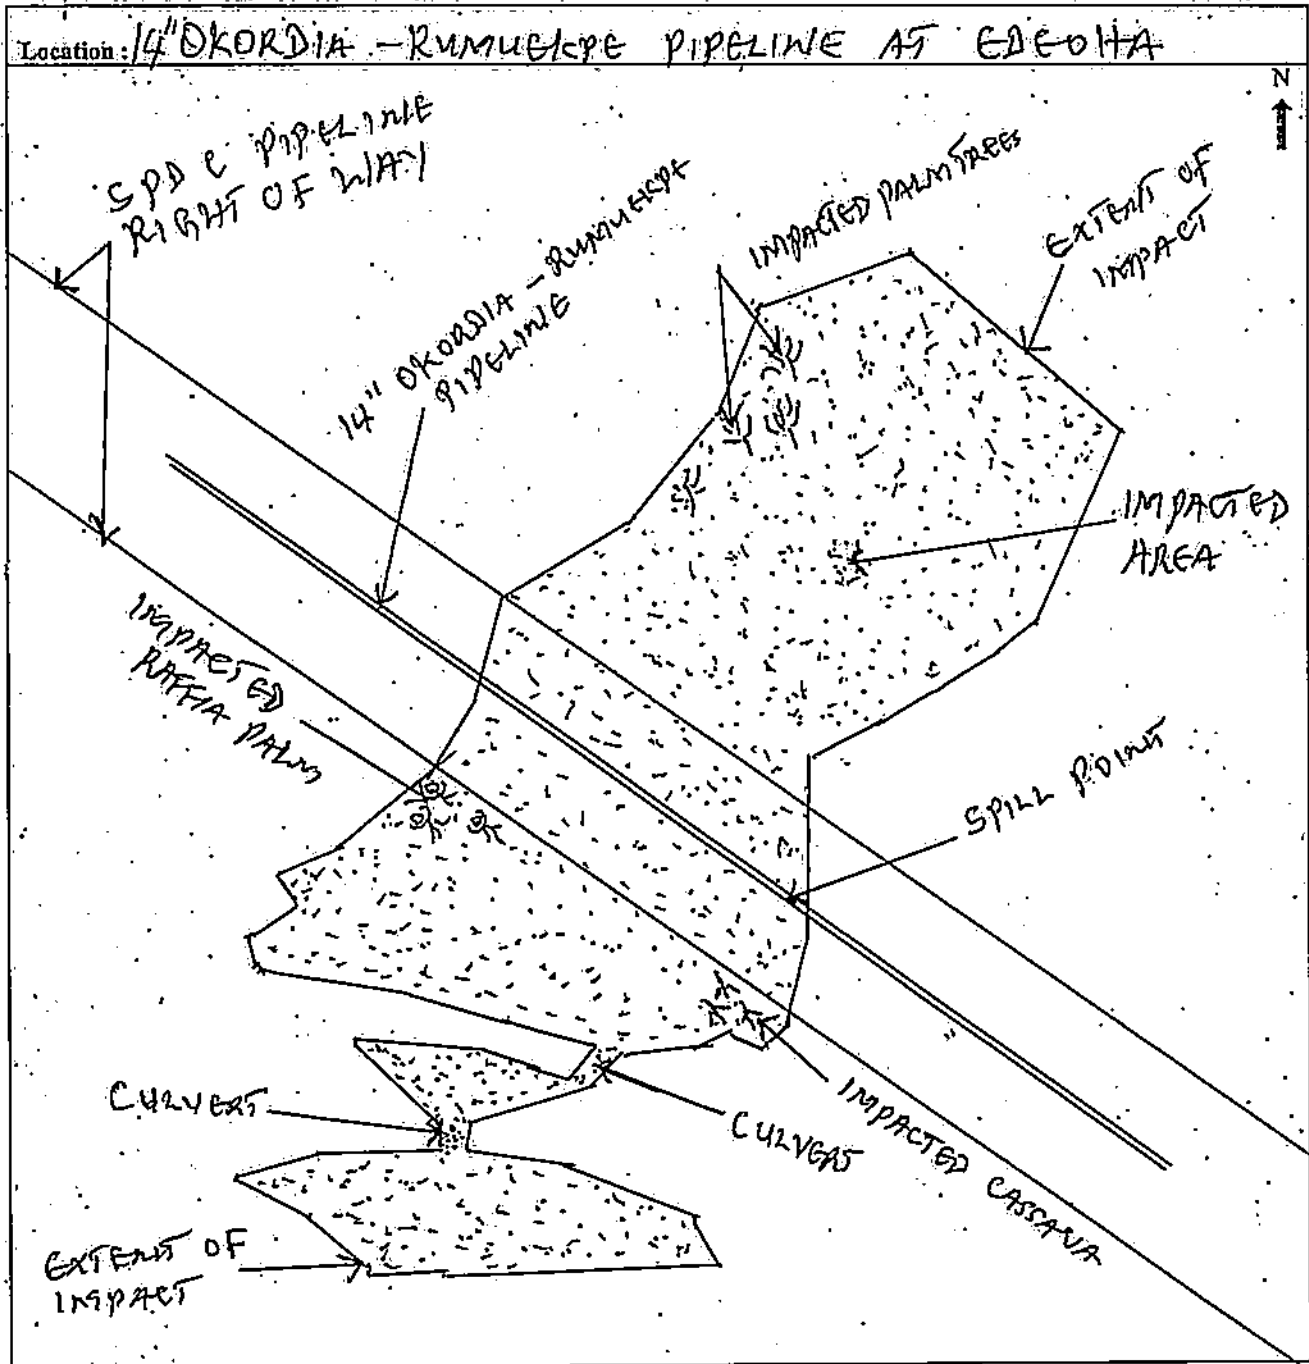
f. Appendix d: Overview sketch of the site

- Total calculated area of impact 4.72 HA
- Impact within SPDC R.O.W. YES
- Impact outside SPDC R.O.W. YES
