JOINT INVESTIGATION REPORT

INCIDENT NO: 2424028 JIV report S/N: 1030084

1. Fountain Incident Number: 2424028 2. Type of incident* OIL SPILL
3. Name of Location 12" IMO RIVER - OGAGE PIPELINE
4. Name of nearest community OWAZA 5. State: ABIA 6. LGA UKWA WEST
7. Type of Production facility/Installation OIL PIPELINE
8. Asset owner/District THE SHELL PETROLEUM DEVELOPMENT COMPANY OF NIGERIA LTD (SPDC) / PIPELINE

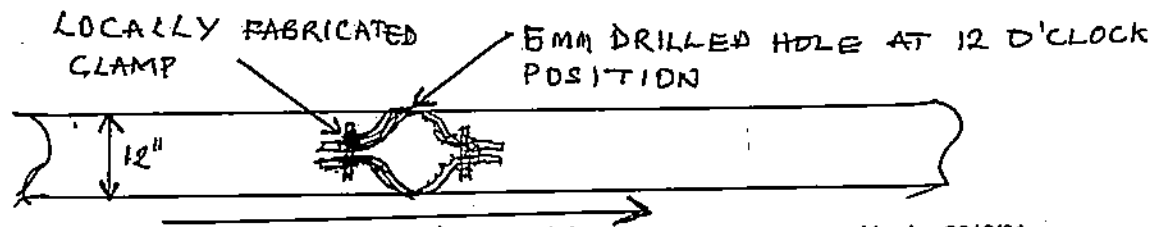
Additional observations around the spill point: THE TEAM OBSERVED A LOCALLY FABRICATED CLAMP AND DRILLED HOLE AT 12 O'CLOCK POSITION.

E. GRAPHIC DESCRIPTION OF LEAK POINT (while detail report of the leak point should be contained in the leak report, overview sketch of the site should be added as an appendix 1) A SECTION OF 12" IMD RIVER - OGALE PIPELINE AT OWAZA SHOWING 5MM DRILLED HOLE AT 12 O'CLOCK POSITION AND LOCALLY FABRICATED CLAMP, DONE BY UNKNOWN PERSONS,
