JOINT INVESTIGATION REPORT

INCIDENT NO: 2434200 JIV report S/N: 1030126

1. Fountain Incident Number: 2434200 2. Type of incident* OPERATIONAL FAILURE
3. Name of Location E TELEBOU FLOWN STATION SAVER PIT
4. Name of nearest community OGBOLOMA State: BAYELSA LGA YENAGOA
7. Type of Production facility/Installation (PEDE) PD METER/SAVER PIT
8. Asset owner/District THE SHELL PETROLEUM DEVELOPMENT COMPANY OF NIGERIA LTD
GBARAN-KOLO CREEK

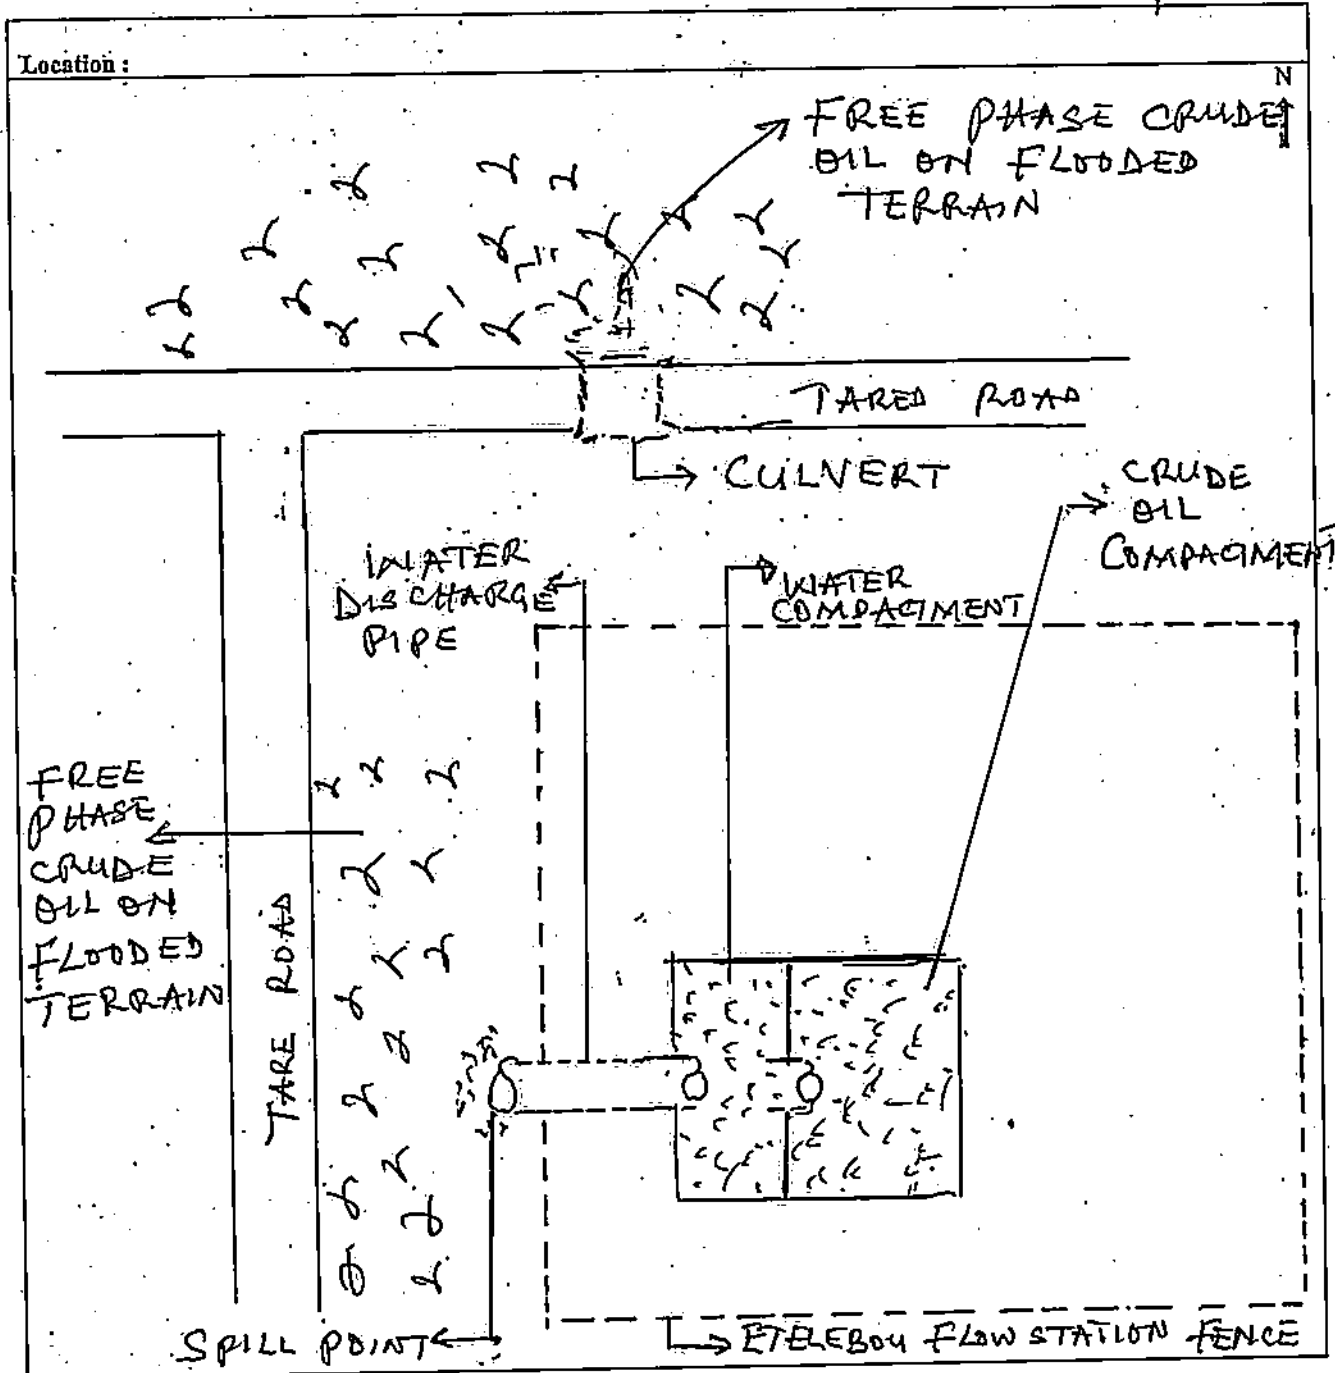
f. Appendix I: Overview sketch of the site

During a PDM Switching operation, a drain valve in the train was suspected to be in an open position which led to ^{the} oil to the environment through the saver pit.
