JOINT INVESTIGATION REPORT

INCIDENT NO: 2439185 JIV report S/N: 1030027

1. Fountain Incident Number: 2439185 2. Type of incident: OIL SPILL
 3. Name of Location: 24th NKPOKU - BOMU PIPELINE (ONP)
 4. Name of nearest community: KPITE 5. State: RIVERS 6. LGA: TAI
 7. Type of Production facility/Installation: OIL PIPELINE
 8. Asset owner/District: THE SHELL PETROLEUM DEVELOPMENT COMPANY OF NIGERIA LIMITED/ PIPELINE

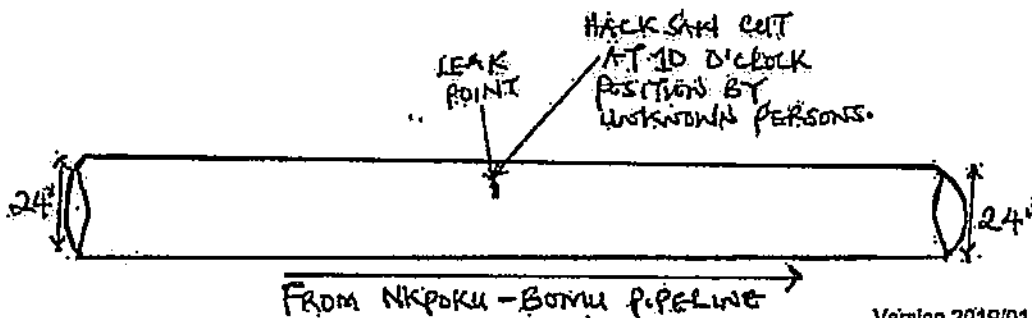
A SECTION OF 24" NKPOKU - BOMU PIPELINE AT KPITE SHOWING A HACK SAW CUT AT 10 O'CLOCK POSITION BY UNKNOWN PERSONS.

REPAIR BY CLAMPING
